END OF TERM **FINAL REPORT**

Mr. Donchai Manasphrom

Architect

at Tourism Council of Bhutan (TCB)

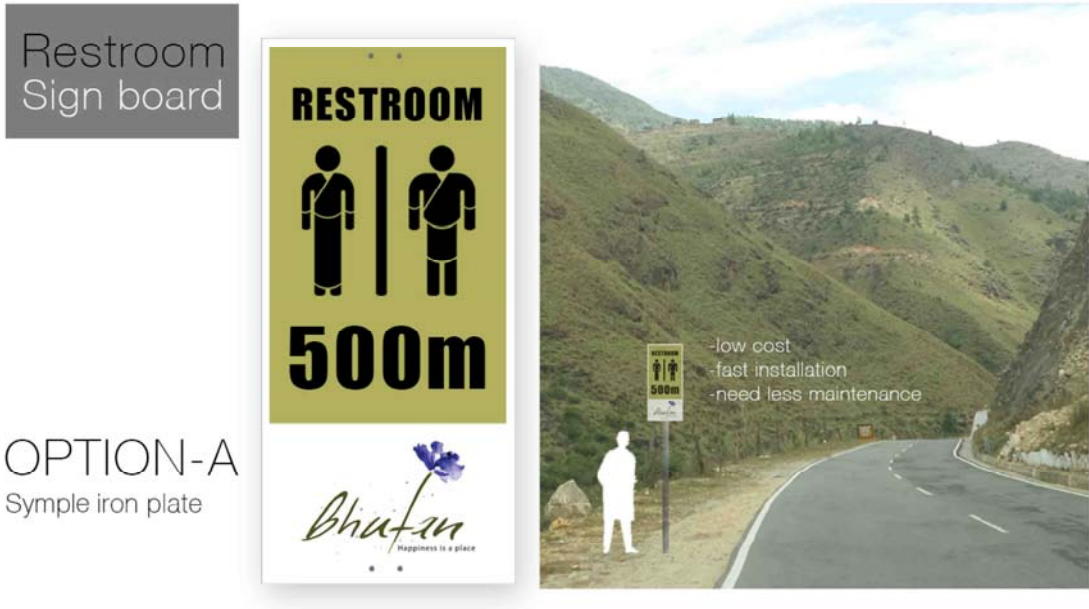
Figure Q1-07. Restrooms signboard option-A

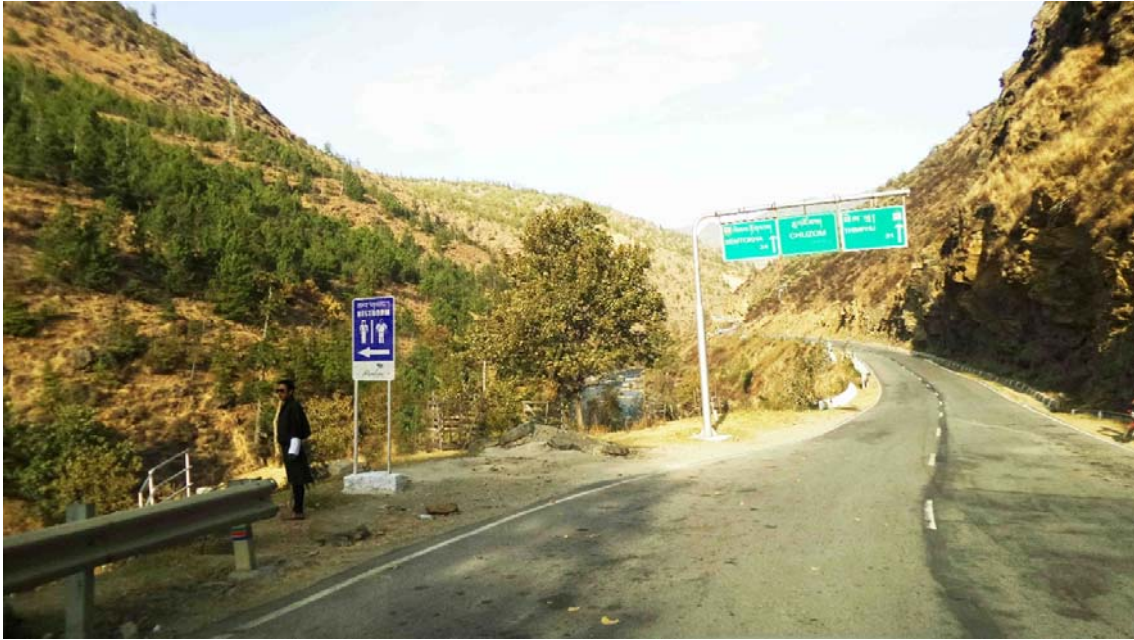
Figure Q1-09. Restrooms signboard presentation perspective

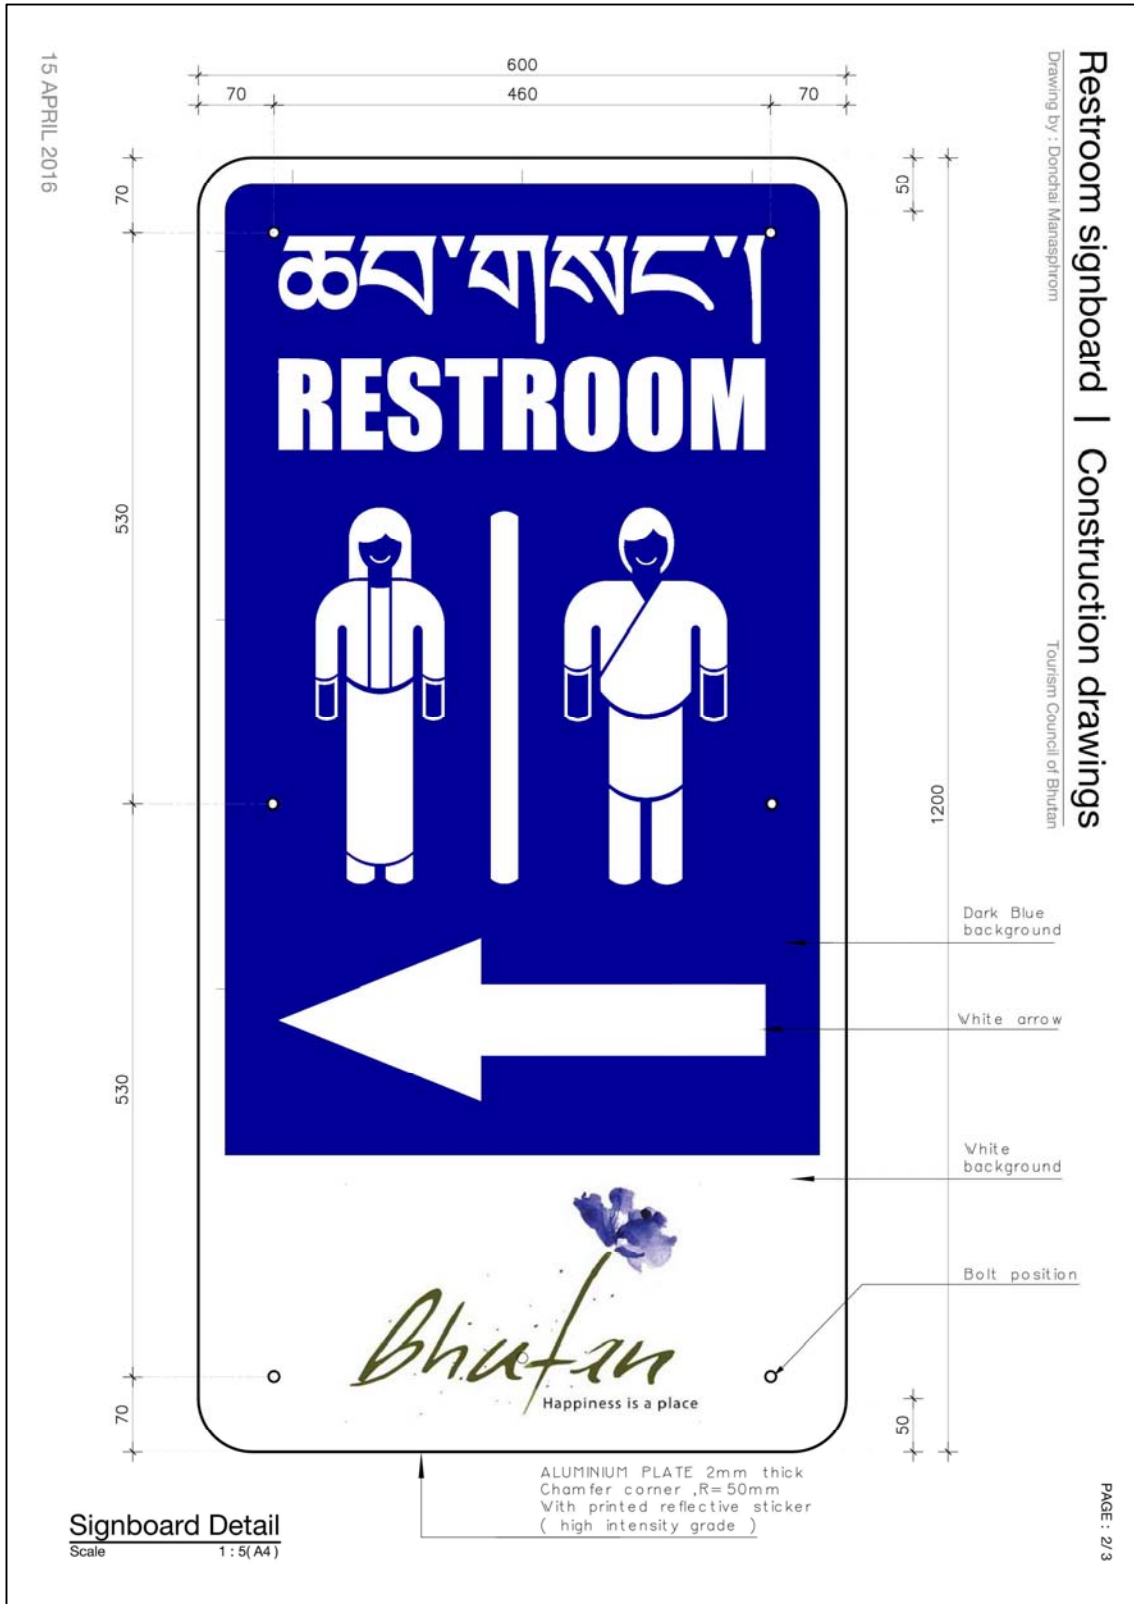
Figure Q1-11. Restrooms signboard final production drawings

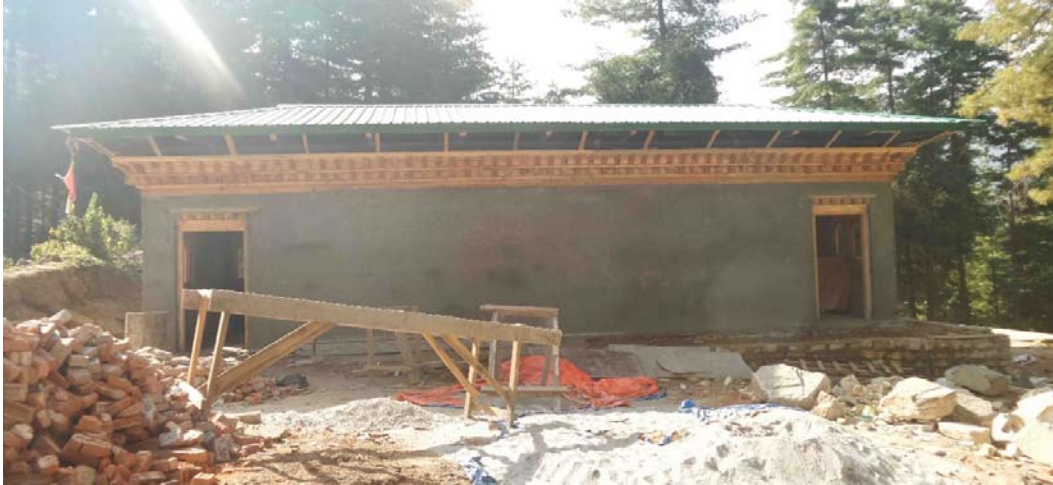
Design development of Ramthangkha restrooms which was in construction process.

Figure Q1-12. Existing façade of Ramthangkha (Taksang base) restrooms construction

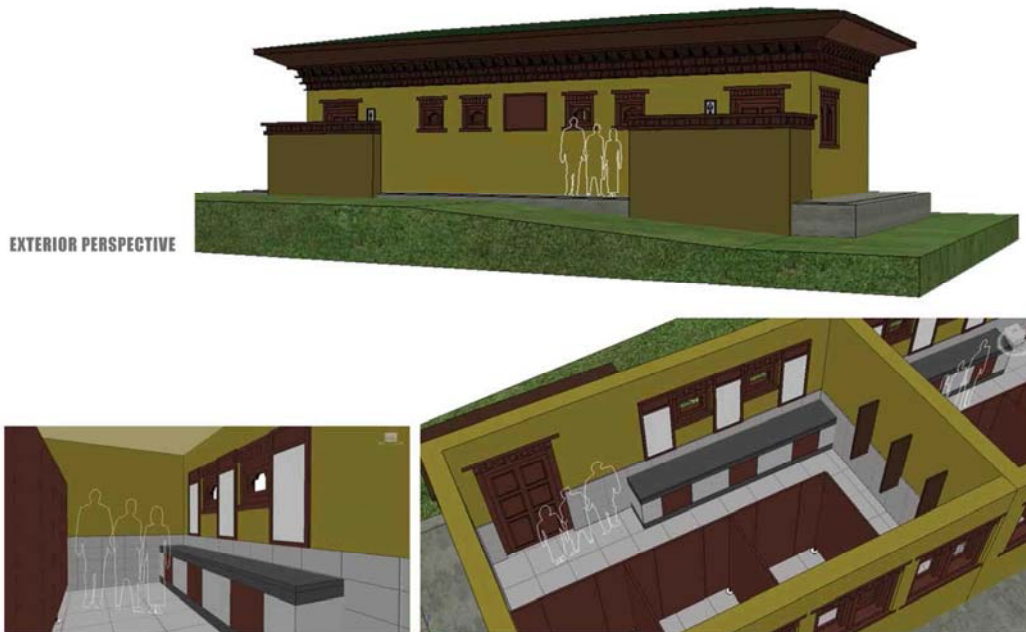
Figure Q1-13. Presentation design perspective of Ramthangkha (Taksang base) restrooms construction

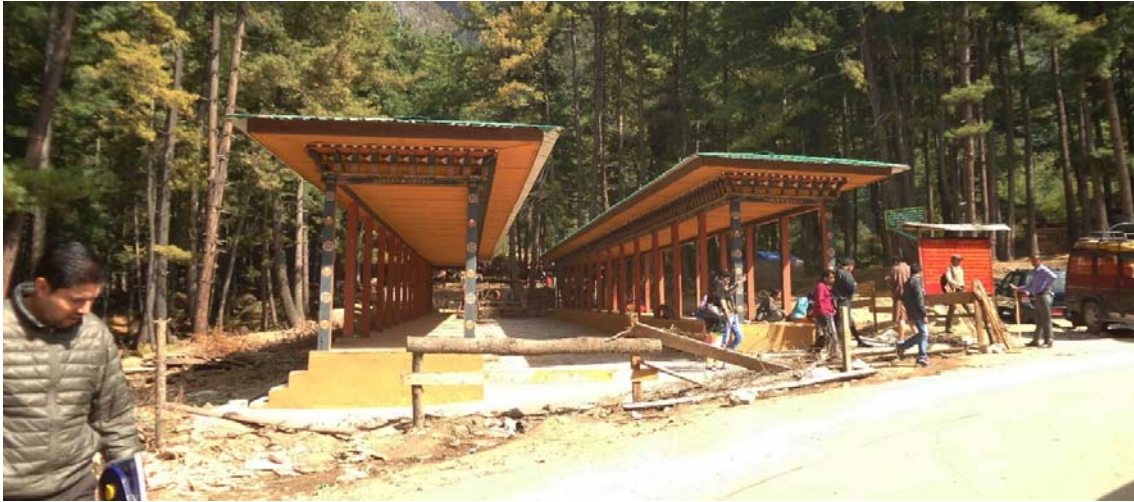
Design of market shed fence to block horses from entering the market court area and control the tourist circulation.

Figure Q1-21. Existing market shed at Ramthangkha (Taksang base)

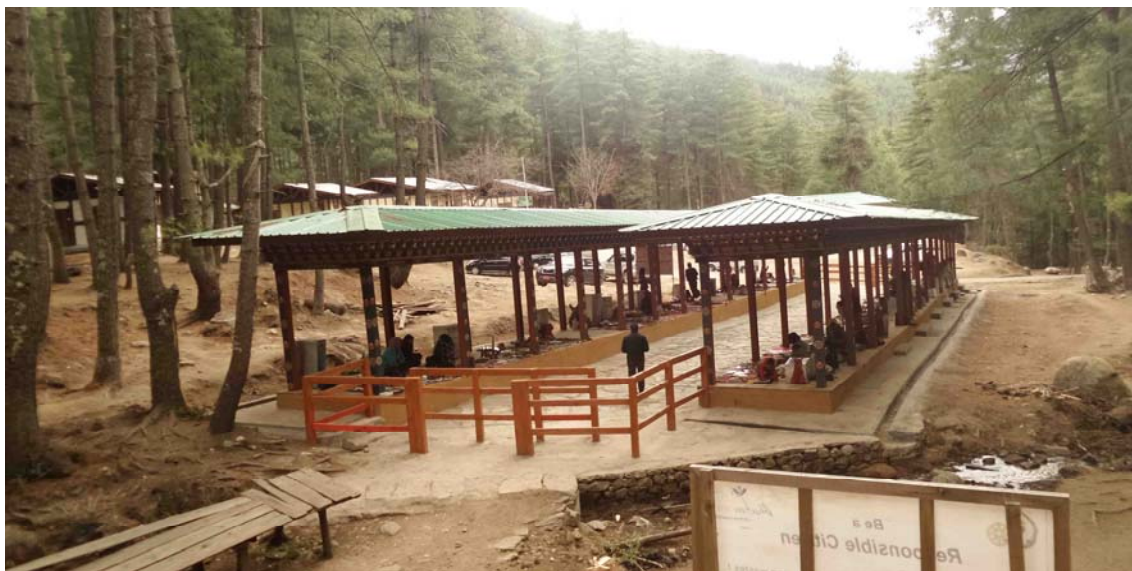
Figure Q1-27. Complete of Ramthangkha market shed fences

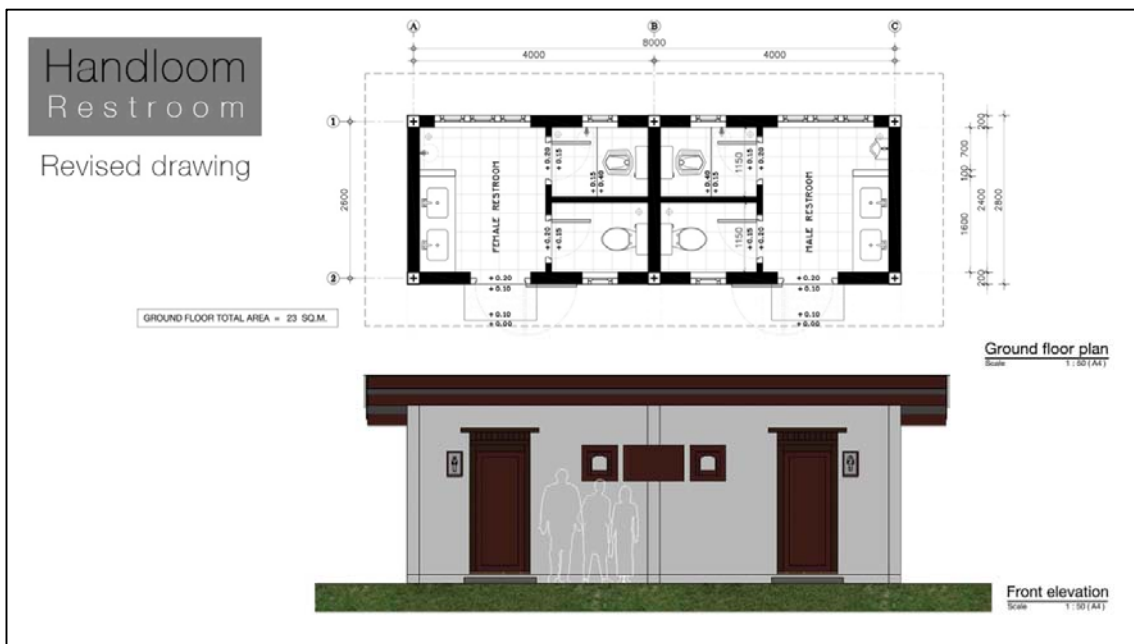
Figure Q1-29. Revision design of Handloom center restrooms

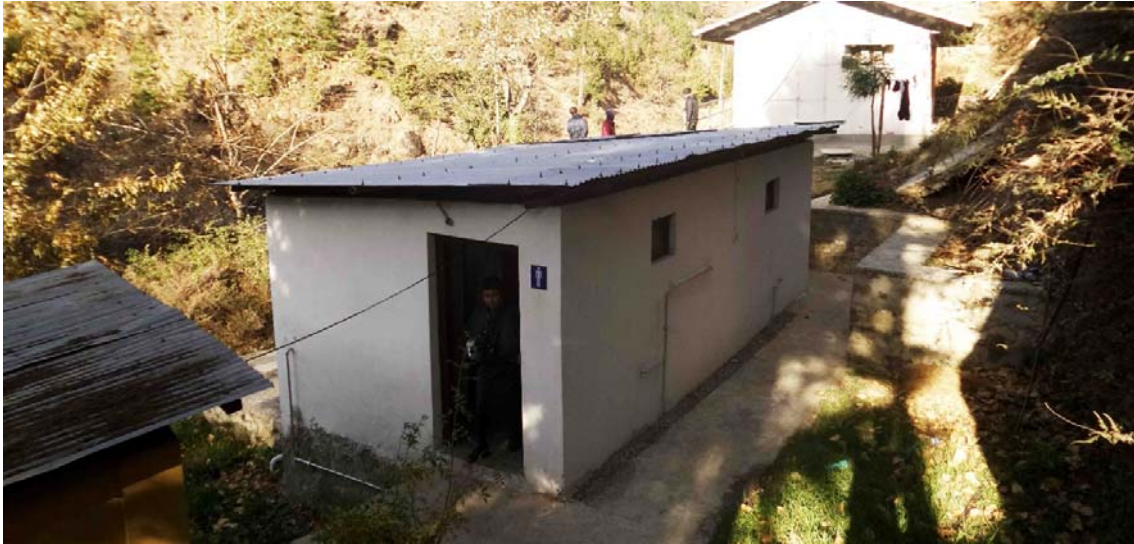
Renovation design of Chuzom restrooms on Thimphu-Paro highway which got problem from leaking roof.

Figure Q1-46. Existing Chuzom restrooms (Thimphu-Paro highway)

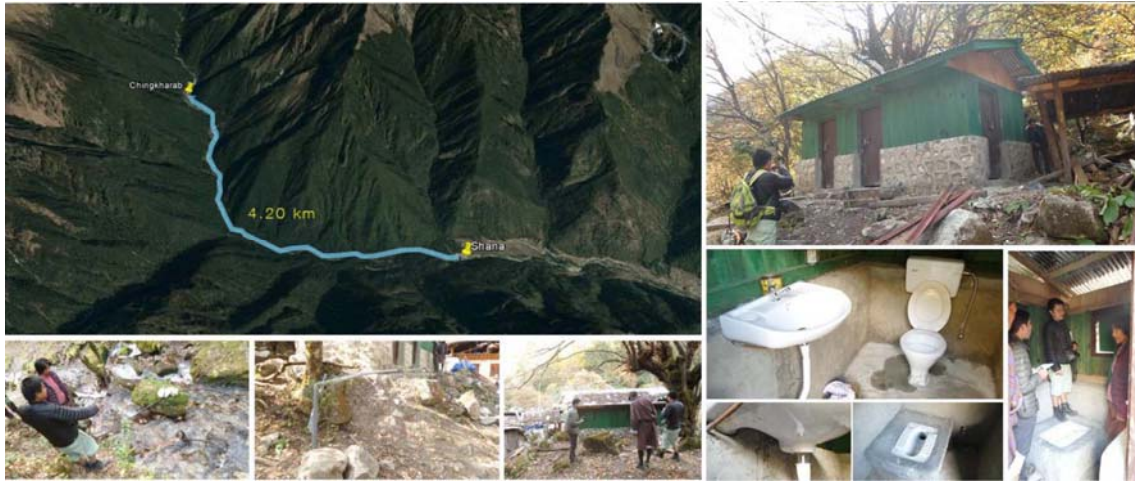
Trekking trip to monitor and recommend the construction of Chingkarab restrooms on the trekking route to Jomohari base camp.

Figure Q1-56. Chingkarab restrooms monitoring (Paro)

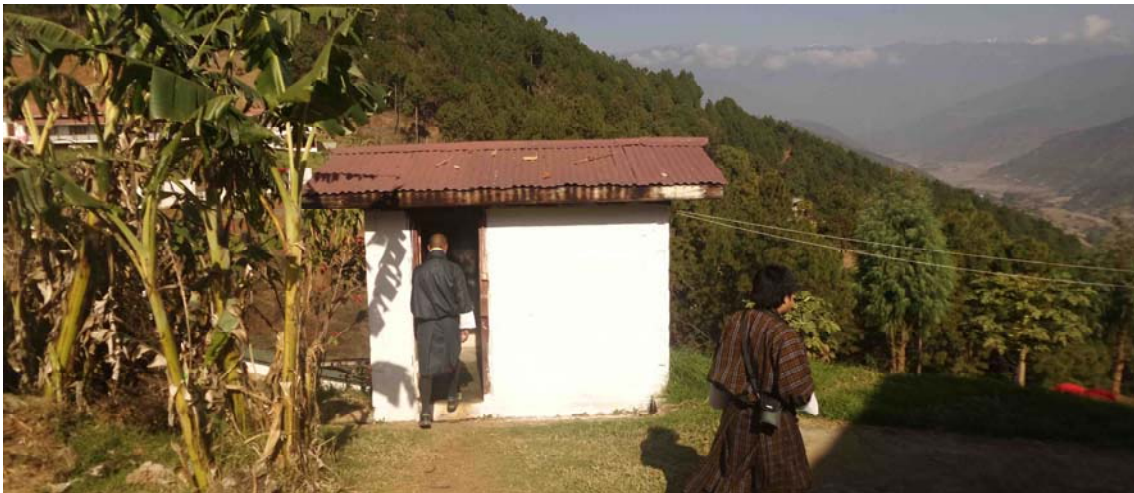
Figure Q2-02. Existing 1 indian-type restroom for all tourists and nuns at Sangchen nunnery (Punakha)

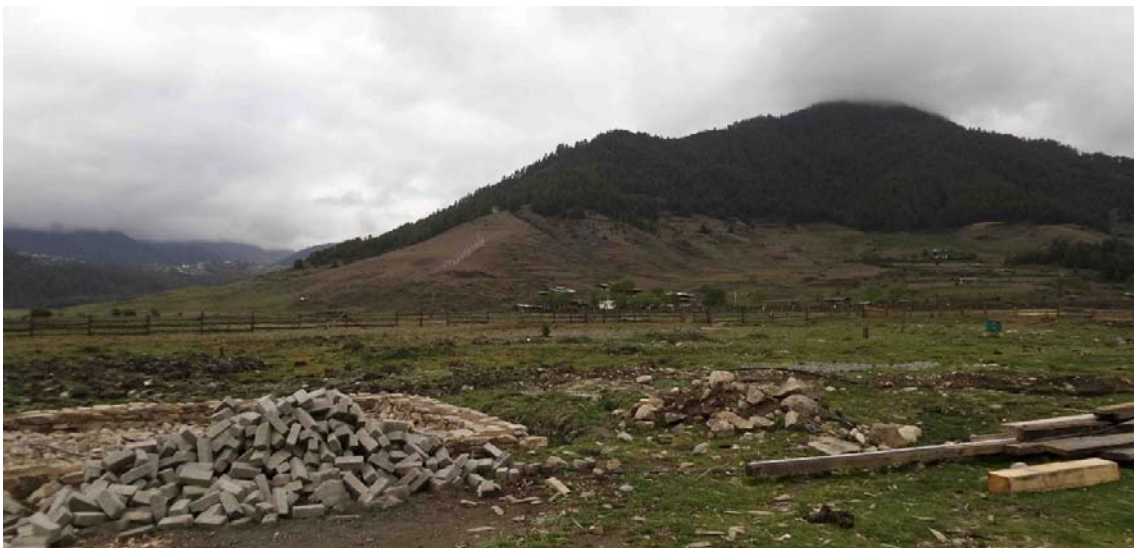
Figure Q2-22. New restrooms location in Pel Khewang Jangchopcholing Shedra.

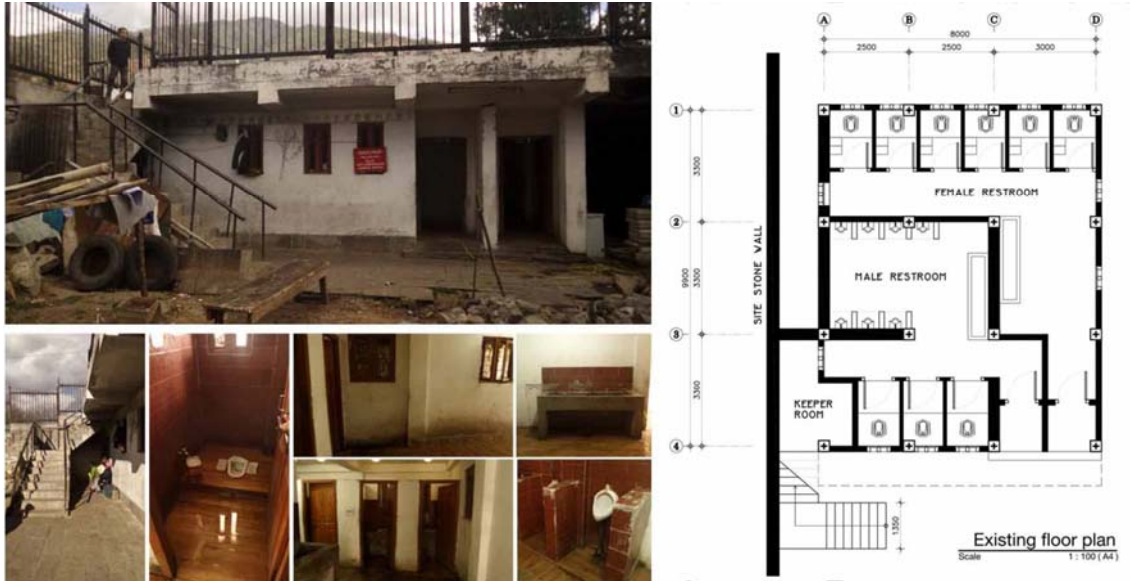
Memorial Chorten is an important landmark temple in Thimphu. The existing pay & use public restrooms is quiet old and dirty because of sanitary problem. The existing indian-type toilet in female restrooms is too high because of improper sanitary pipe design. Urinal drainages are not installed properly, leave bad smell stuck in the solid room.

Figure Q2-46. Existing restrooms at Memorial Chorten.

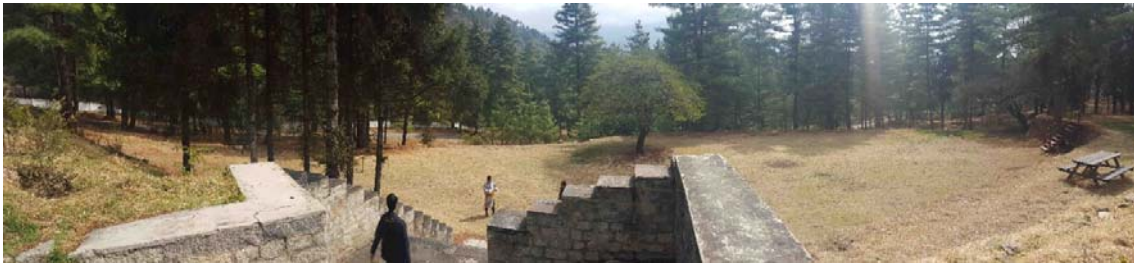
Figure Q2-48. Existing site measurement for lighting poles

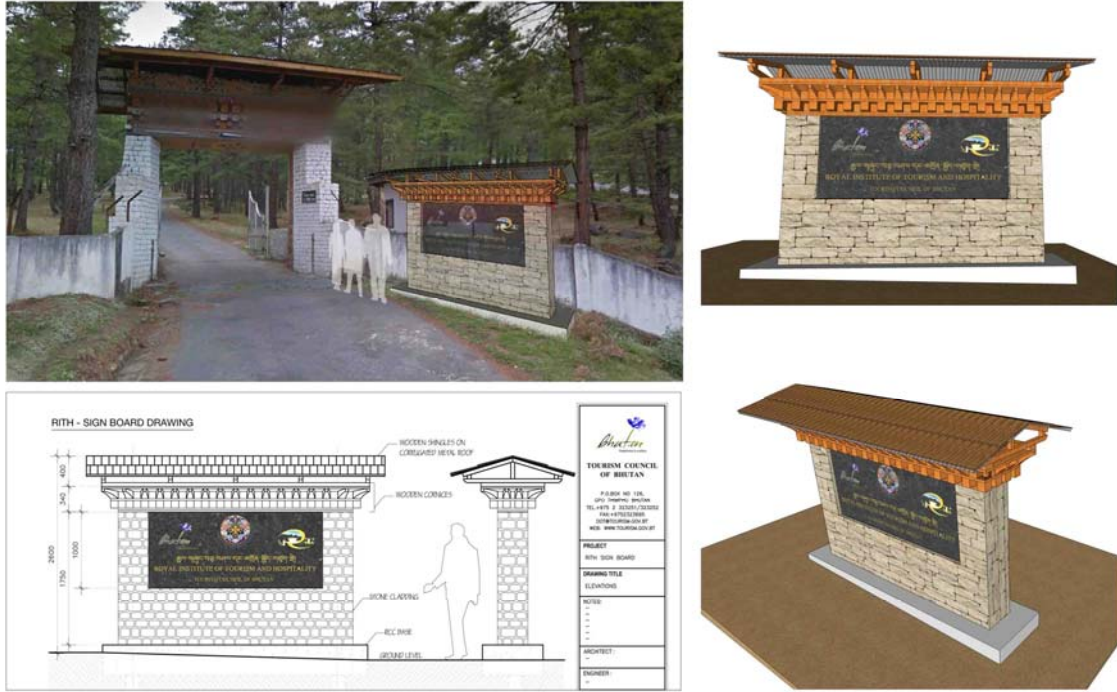
Figure Q2-50. Presentation drawings of RITH entrance signboard

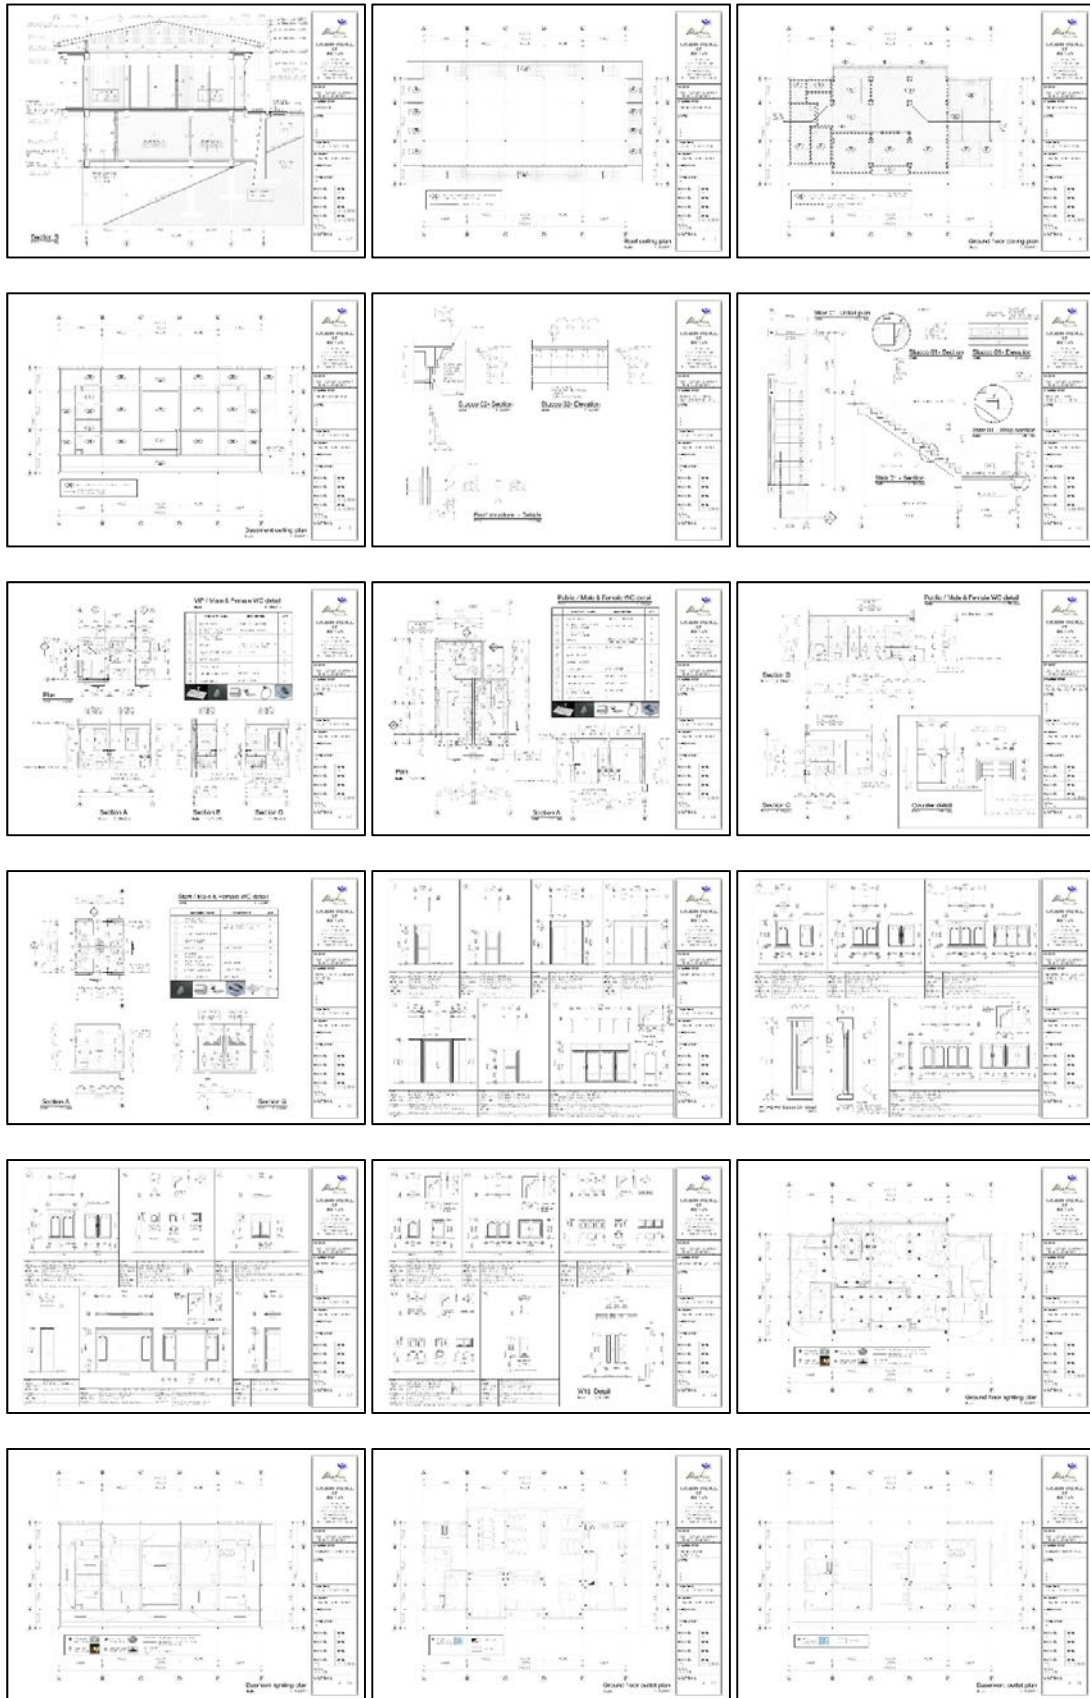
Figure Q2-79-96. Construction drawings of Dorji Goenpa cafeteria in Trongsa.

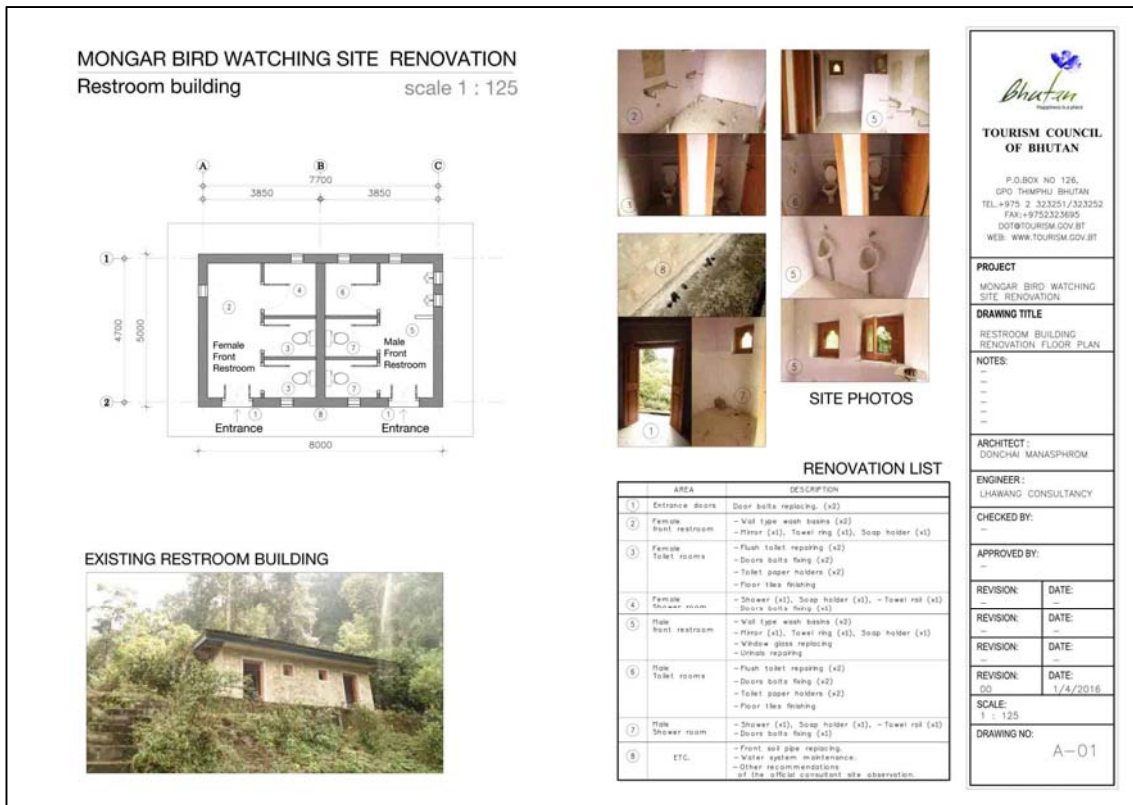
Figure Q2-143. Monitoring report of Mongar bird-watching camp site.

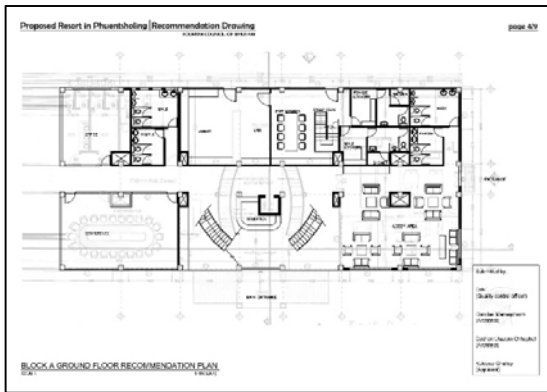
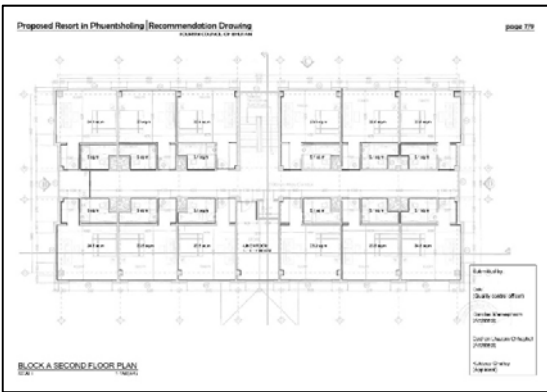
Figure Q2-149-153. Recommendation drawings of Phuentsholing resort.

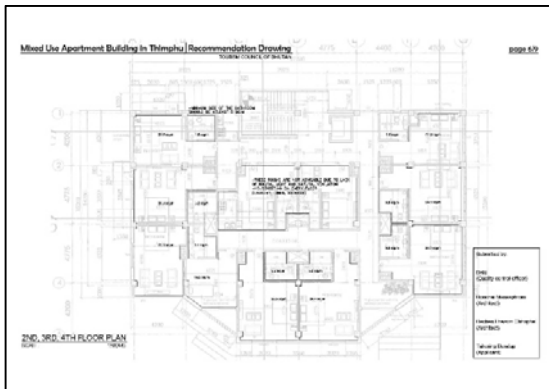
Figure Q2-156-160. Recommendation drawings of Thimphu apartment

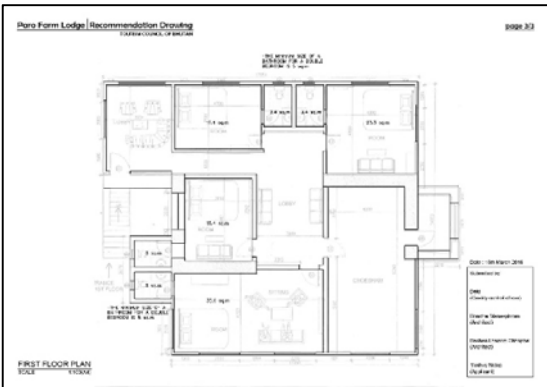
Figure Q2-166-170. Recommendation drawings of Paro farm lodge.

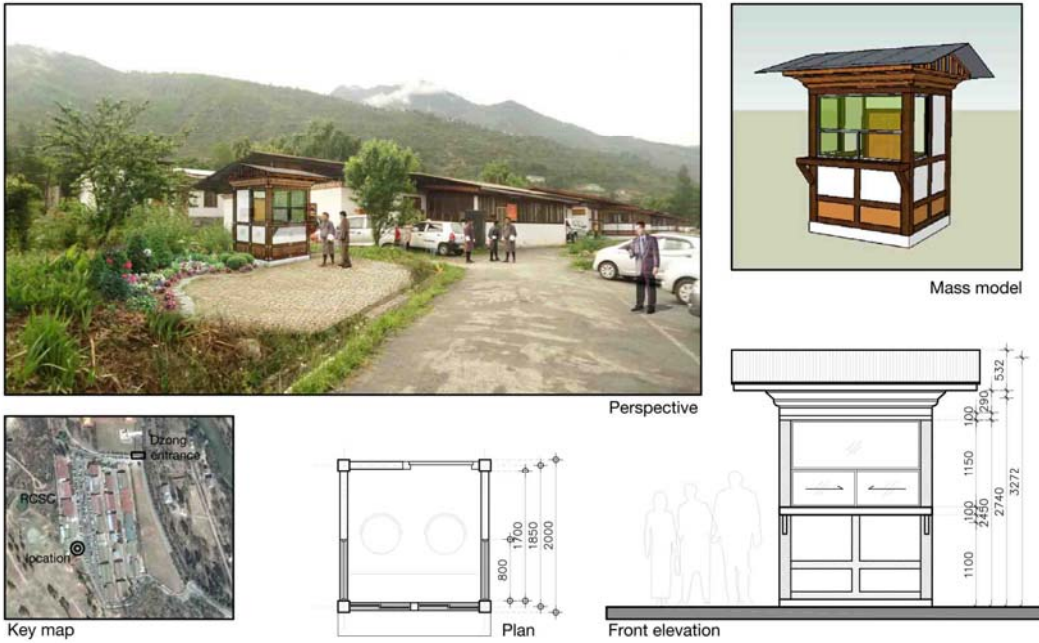
OPTION - A : Stand-alone booth at the parking area

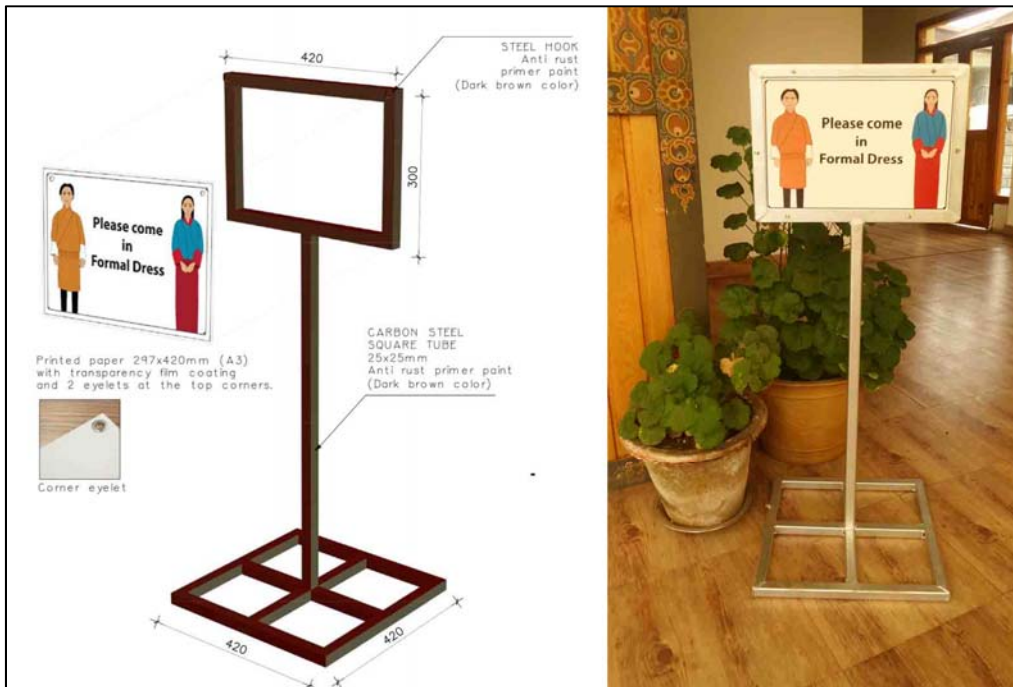
Figure Q3-26,27. Production drawings of TCB signboard stand

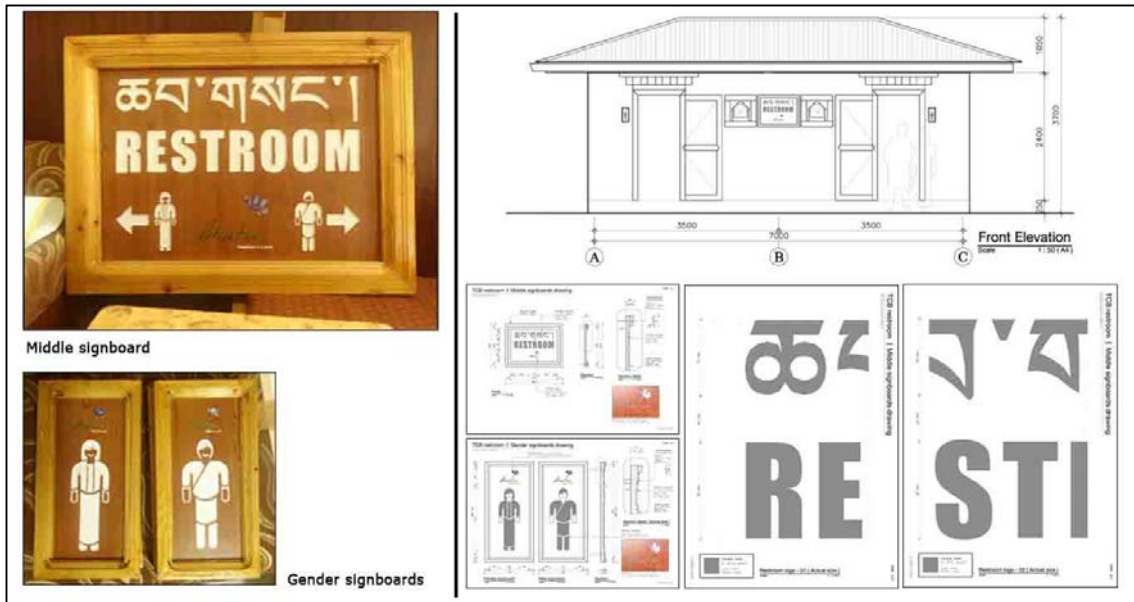
Figure Q3-29. Signboard of Sangchen nunnery & Pel Khewang Sheddra restrooms

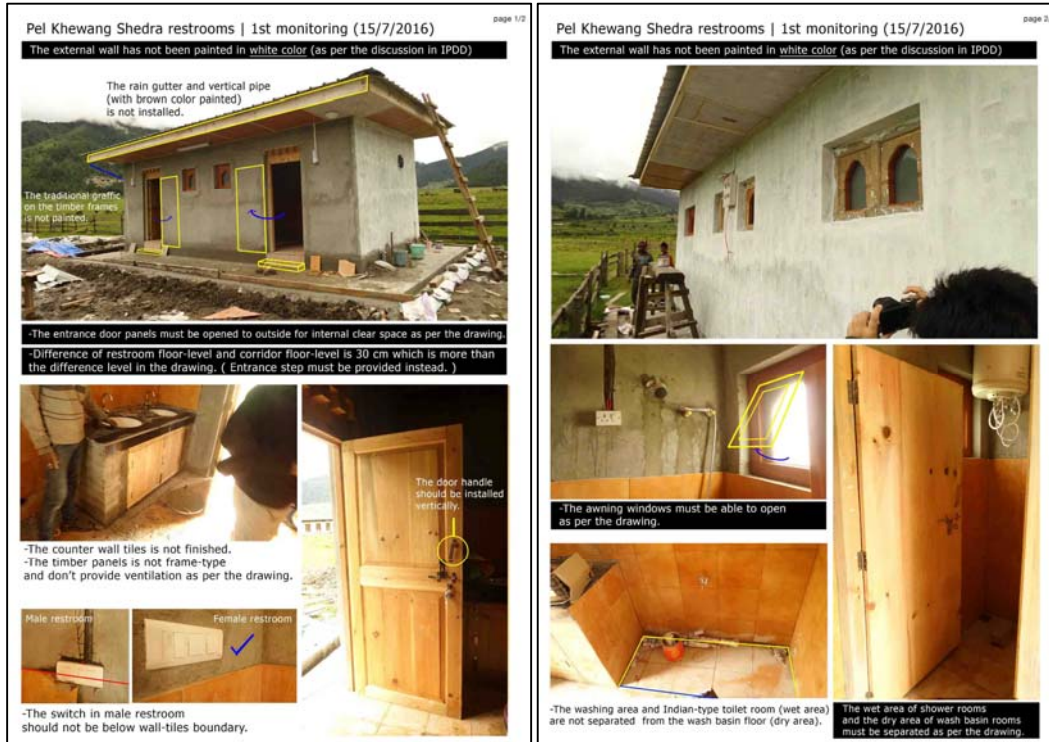
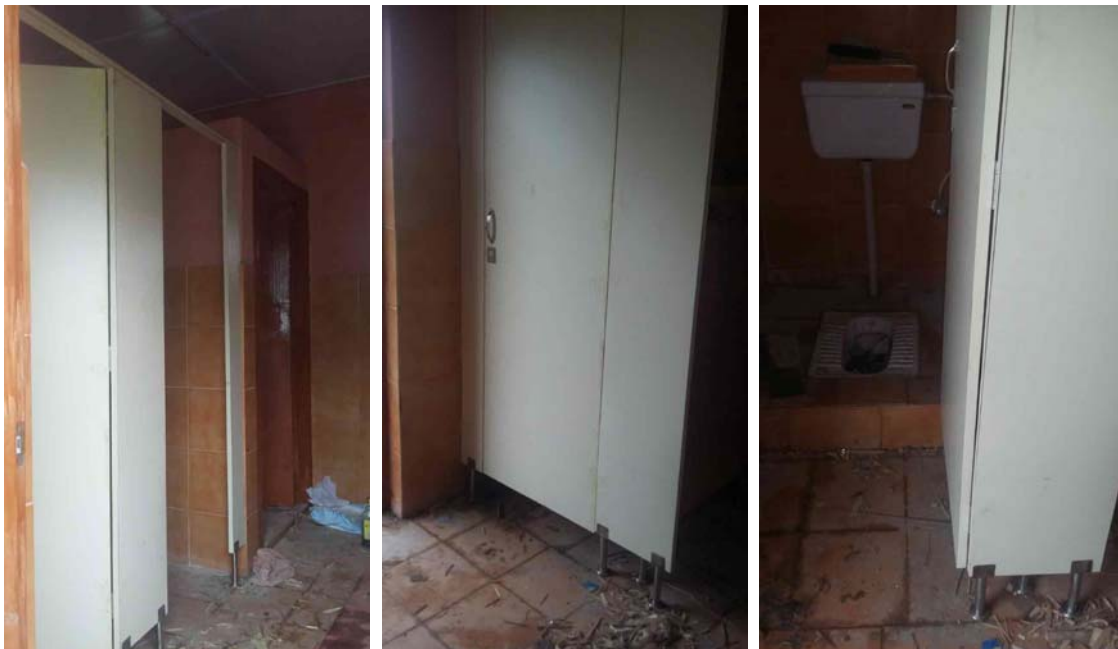
Figure Q3-34-38. Monitoring reports of Khewang Shedra restrooms construction.

Monitoring of restrooms construction at Pel Khewang Jangchopcholing Shedra in Phobjikha.

Project status : under construction

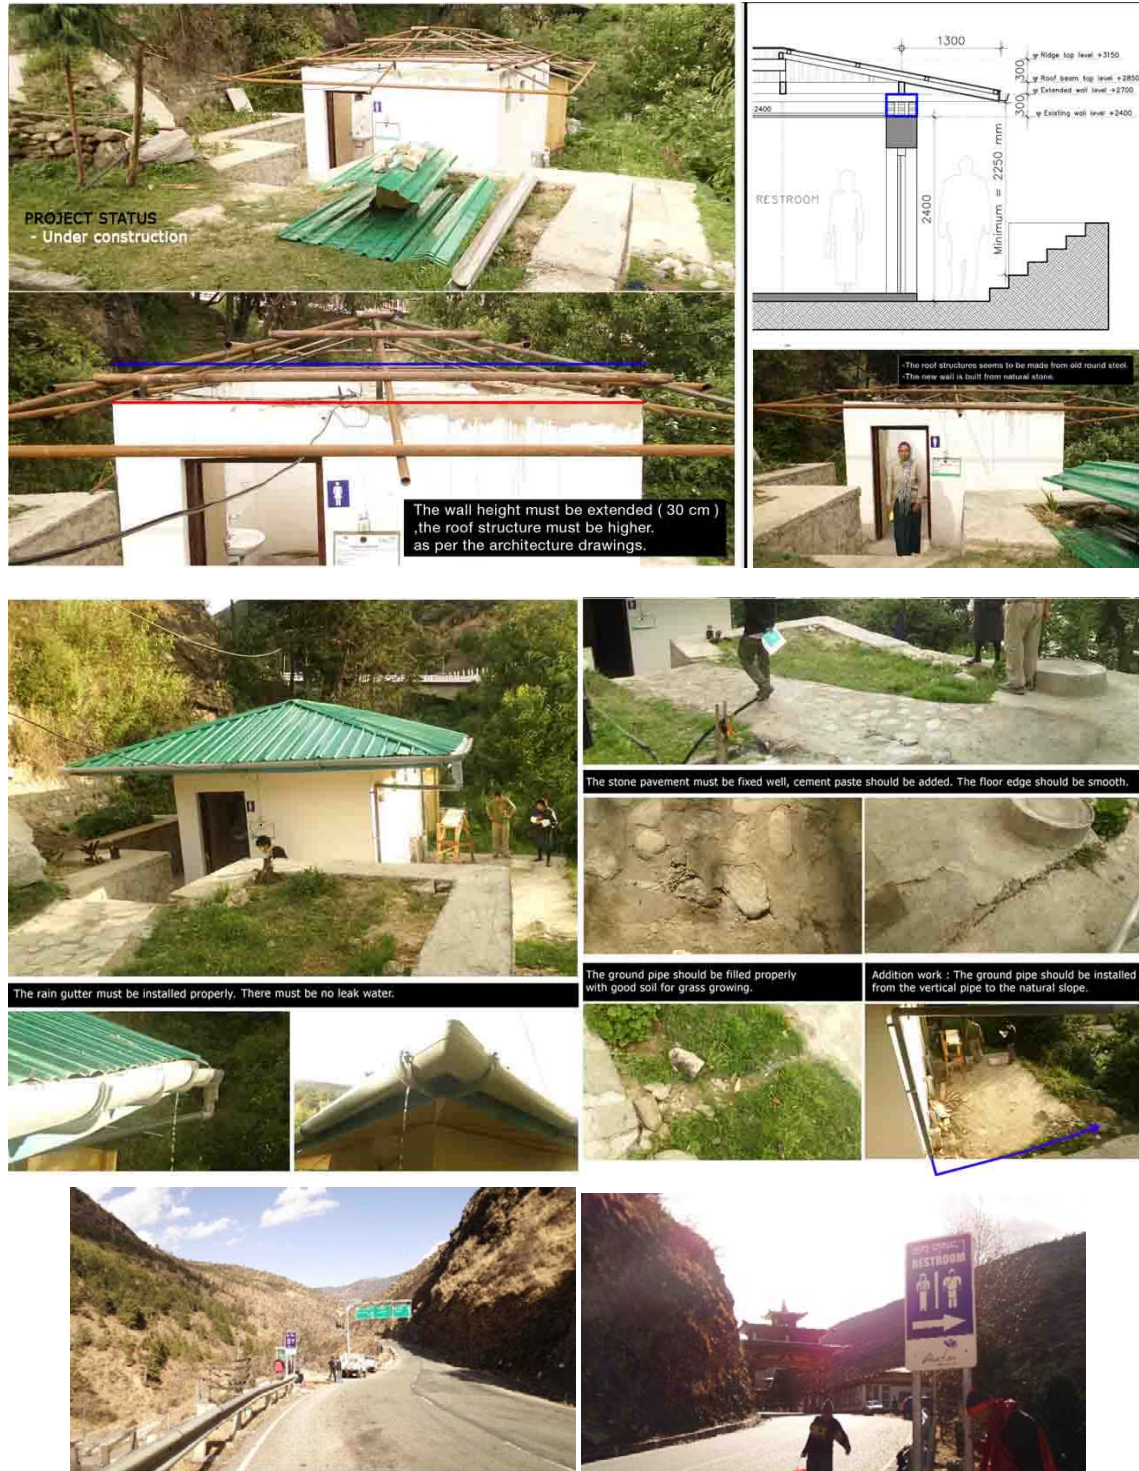
Figure Q3-39-42. Monitoring reports of Chuzom restrooms renovation and signboard installation.

Monitoring of restrooms renovation and signboard installation at Chuzom on Thimphu-Paro highway.
 Project status : under construction

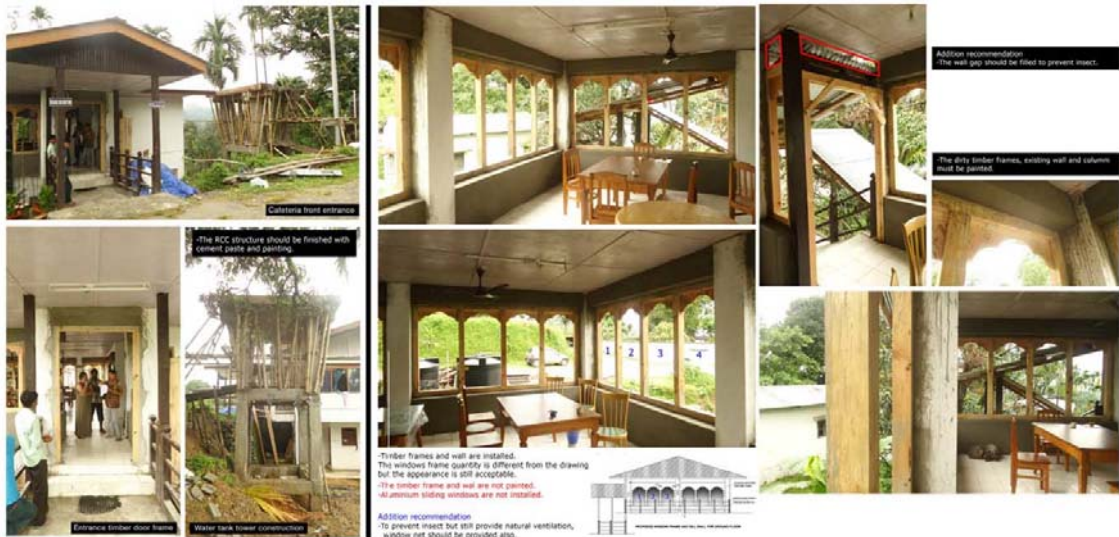
Monitoring of Rinchending cafeteria renovation in Phuentsholing. The site location is in southern Bhutan which is in tropical climate. The renovation is to install window and door to prevent insects.

Retaining wall - A
-To construct the RCC stair at "A" position, retaining wall-A should be provided.
-To protect the existing water tank base from sinking, retaining wall-A should be provided.

Retaining wall - B
-To protect the new water tank tower and the walk way at "B" position from sinking, retaining wall-B should be provided.

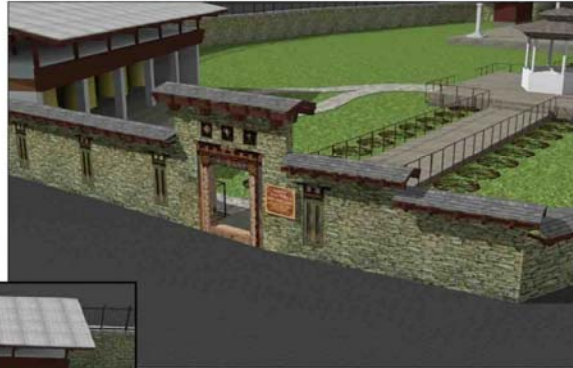
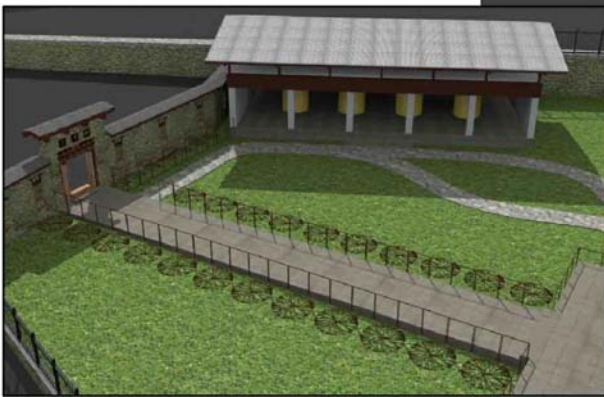
Figure Q4-14. Existing entrance gate of Memorial Chorten.

Existing entrance wall

entrance gate

entrance corridor

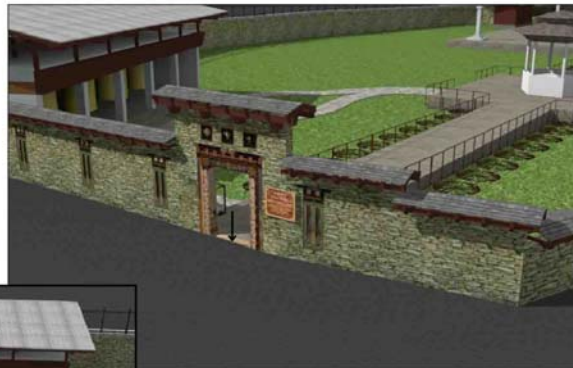
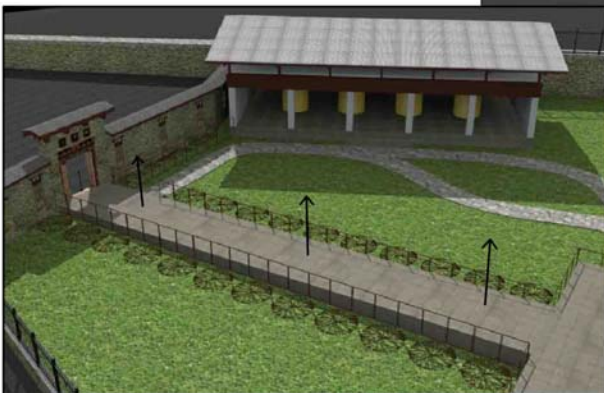
Figure Q4-15. Option-A new entrance gate of Memorial Chorten.

- Remove the timber beam of the gate (Genthoe)
- Increase the entrance corridor level

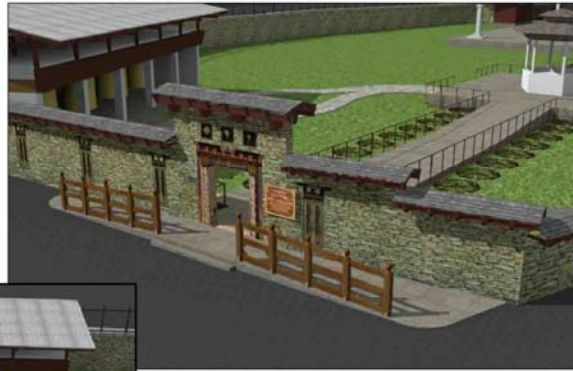
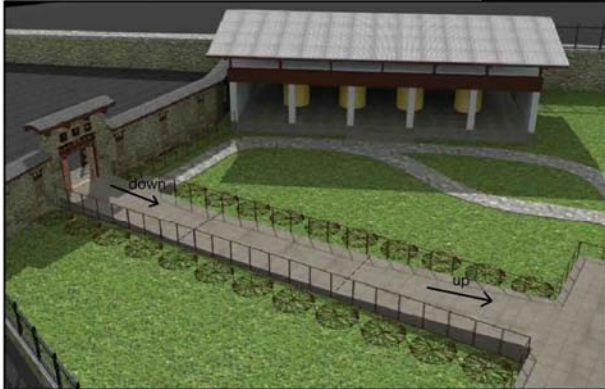
Figure Q4-16. Option-B new entrance gate of Memorial Chorten.

- Add the entrance ramp footpath
- Add slope ramp at the entrance corridor

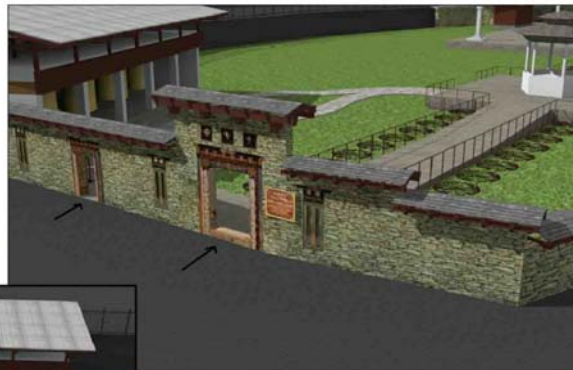
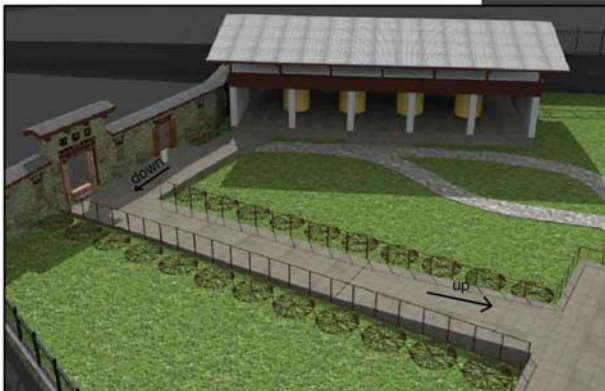
Figure Q4-17. Option-B new entrance gate of Memorial Chorten.

- Add the secondary gate
- Connect the gate to the main pavement
