END OF TERM **FINAL REPORT**

Mr. Donchai Manasphrom

Architect

at Tourism Council of Bhutan (TCB)

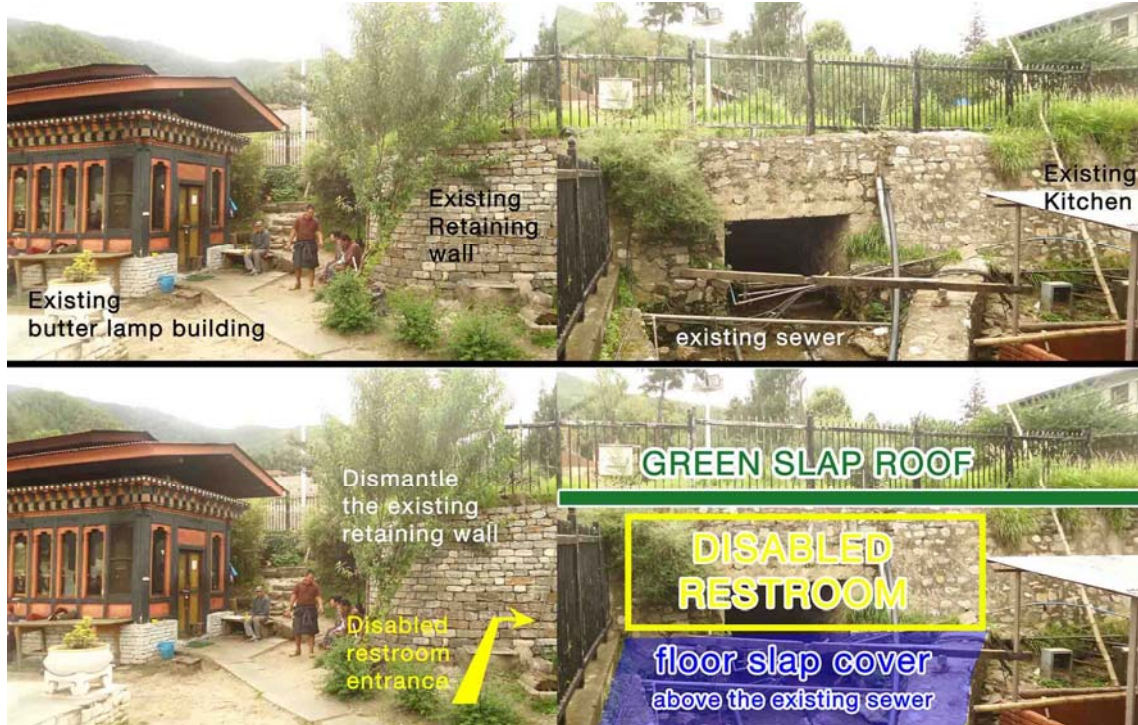
Figure Q4-18,19. Existing site for new disabled restrooms in Memorial Chorten.

Existing site : The north-west corner
 between the butter lamp building & kitchen

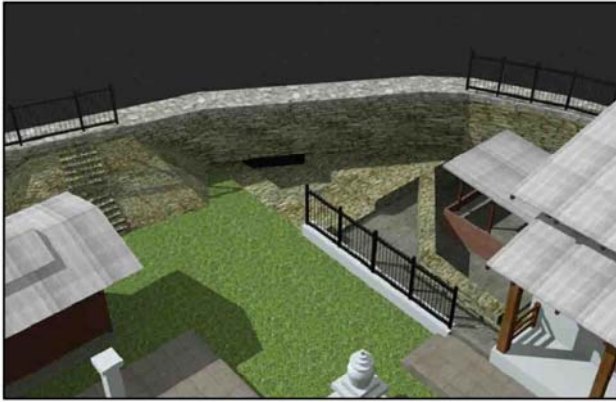
Figure Q4-20,21. Design development and construction plan of new disabled restrooms in Memorial Chorten.

Phase #1 : Dismantle the existing retaining wall and construct new retaining wall with new boundary.

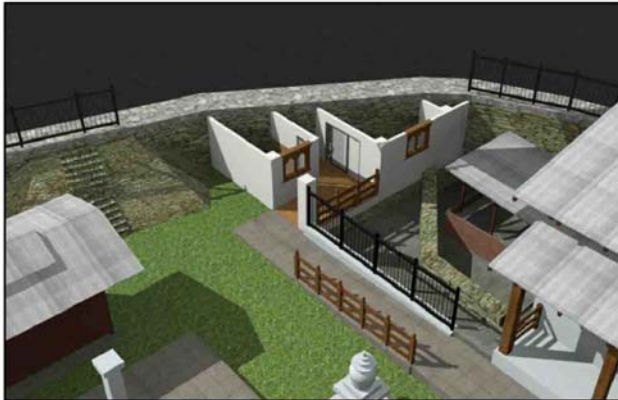
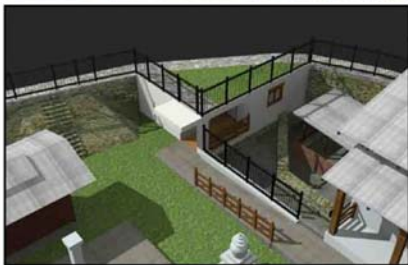
Phase #2 : Construct new restroom with green roof slab, new footpath fence and new ramp for wheel chair.

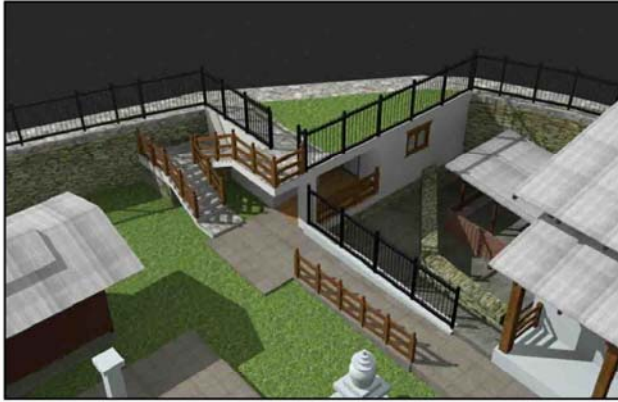
Figure Q4-22,23. Design development and construction plan of new disabled restrooms in Memorial Chorten.

Phase #3 : Dismantle the existing step behind the butter lamp building and construct new staircase with timber railing.

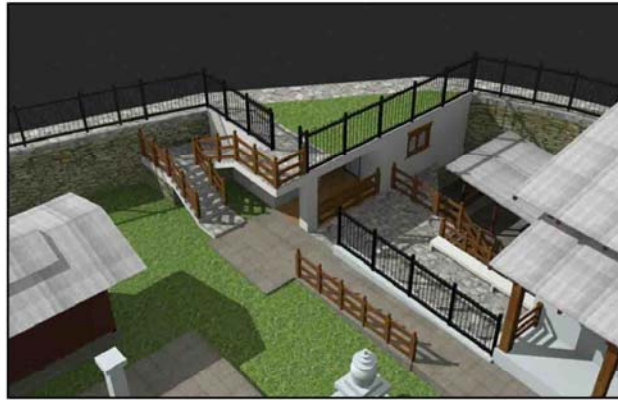
Phase #4 : Dismantle the existing stair to the kitchen and construct new sewer slab-cover with new staircase.

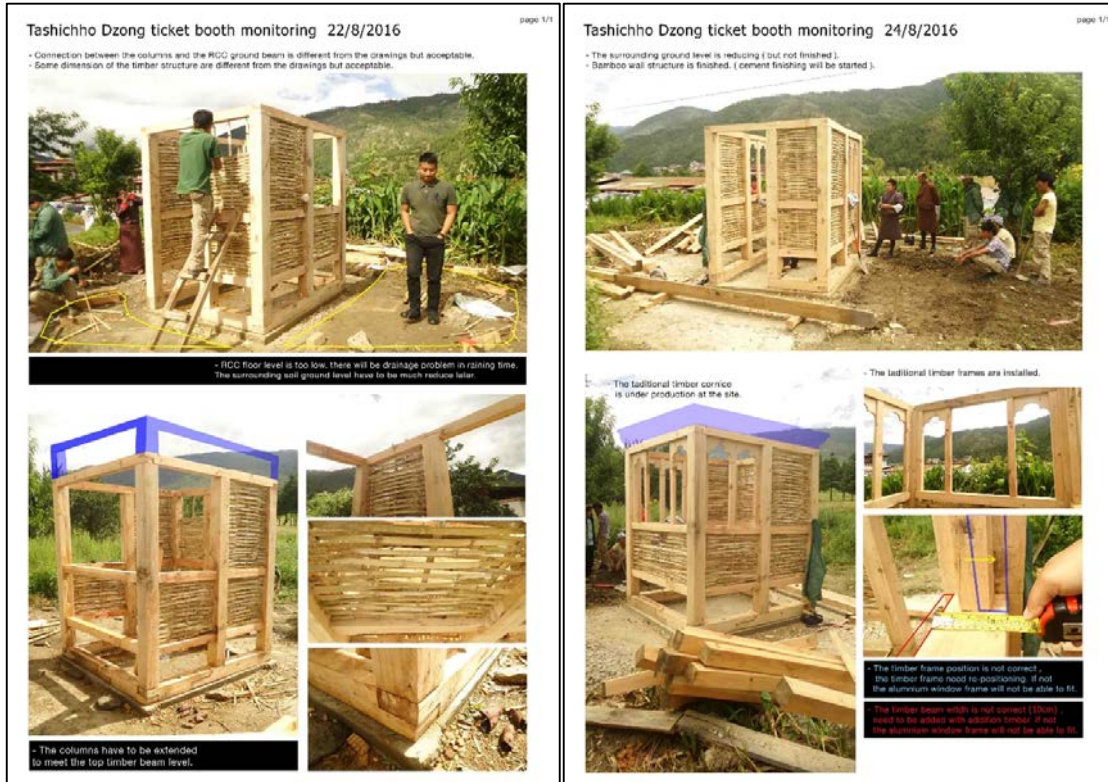
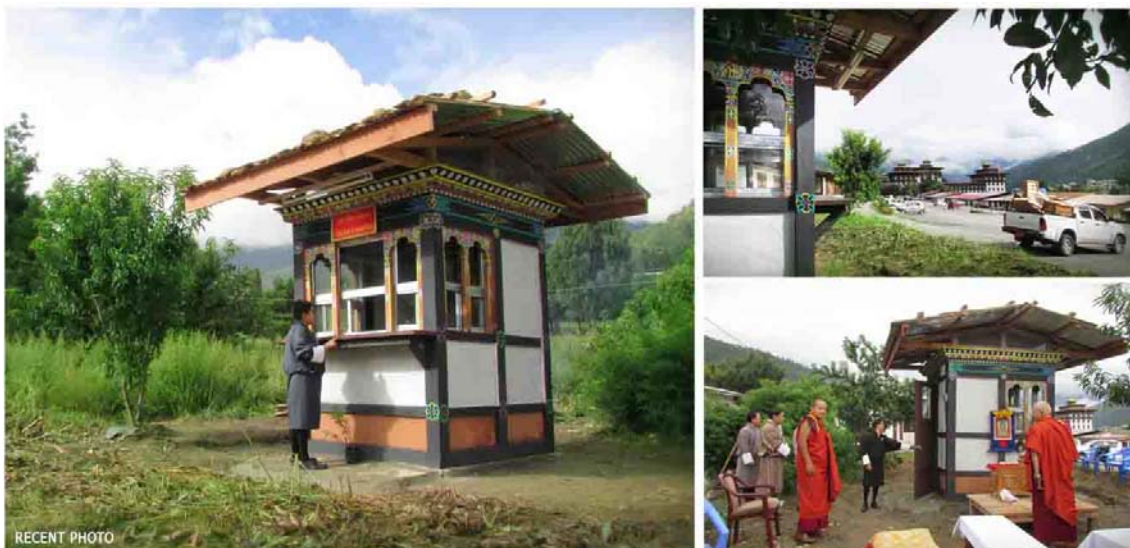
Figure Q4-24-26. Construction monitoring of Tashichho Dzong ticket booth.

Construction monitoring of Tashichho Dzong Ticket booth.

Project status : completed construction

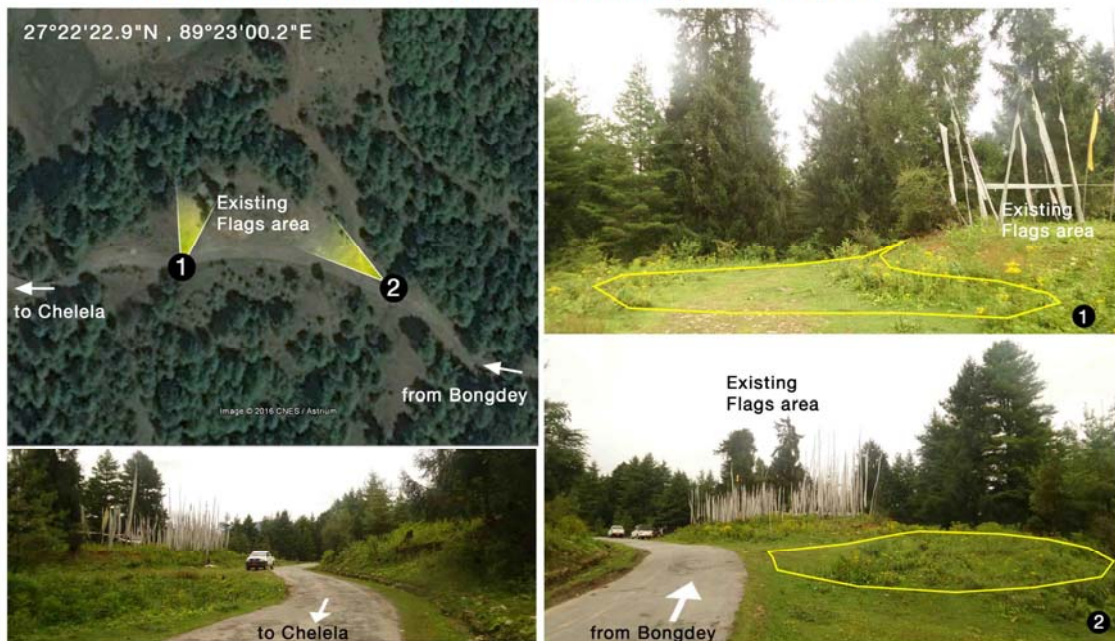
Figure Q4-28. 1st site of Chelela restrooms site survey.

**1st site : The land size is big enough for restroom but too small for cafeteria
 need land extension by cut&fill , existing tree removing and retaining wall.**

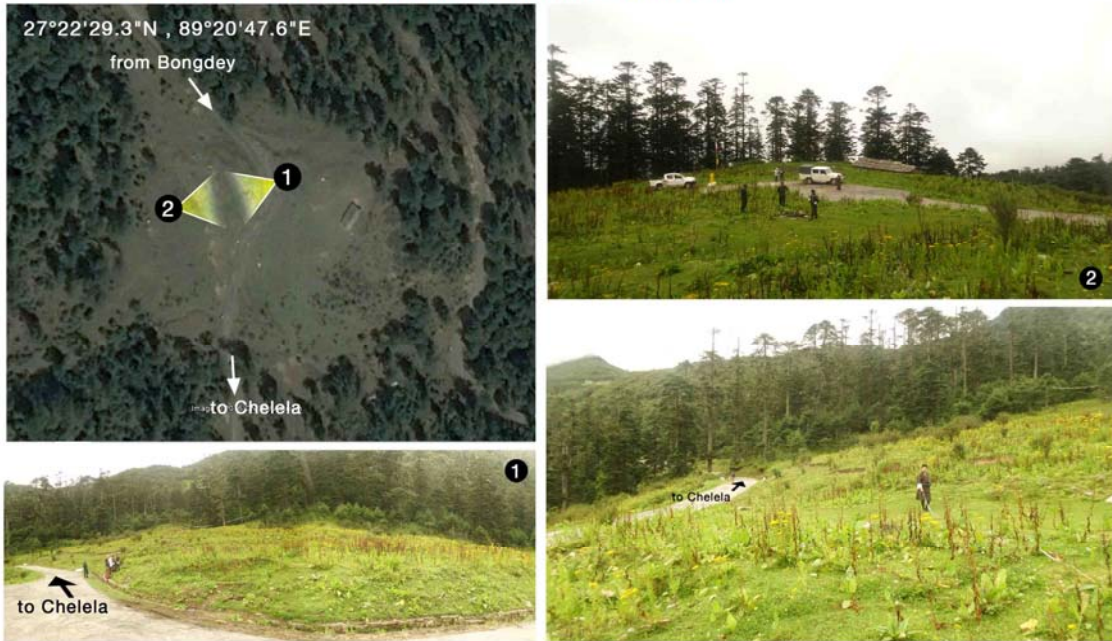
Figure Q4-28. 2nd site of Chelela restrooms site survey.

2nd site : The land size is big enough for restroom and cafeteria
Opened view available , not too far from Chelela pass (4km)

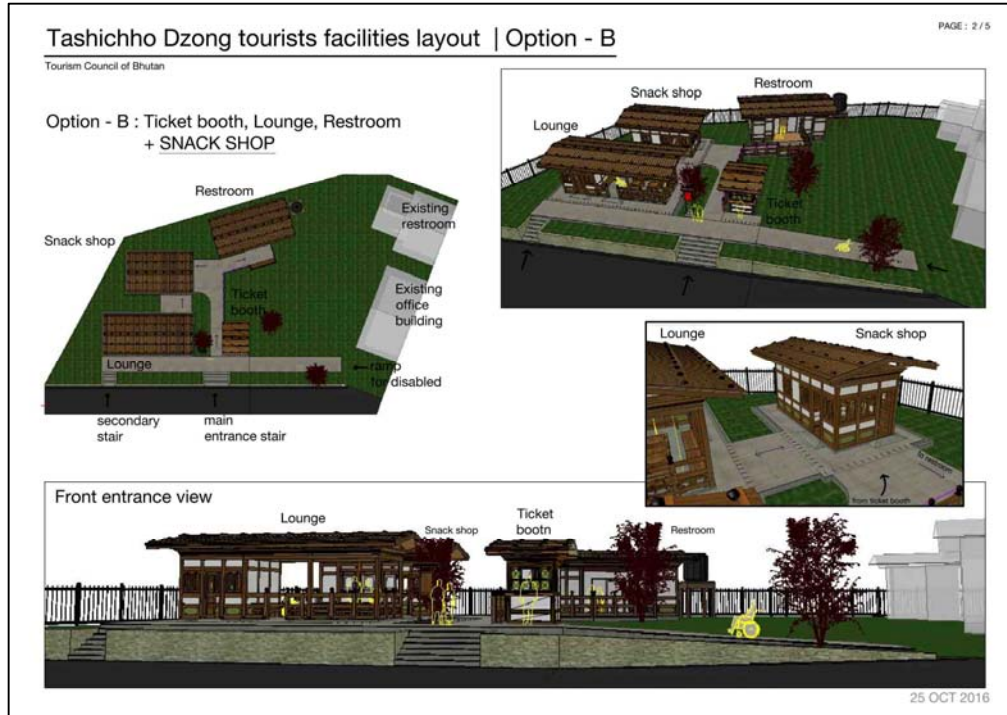
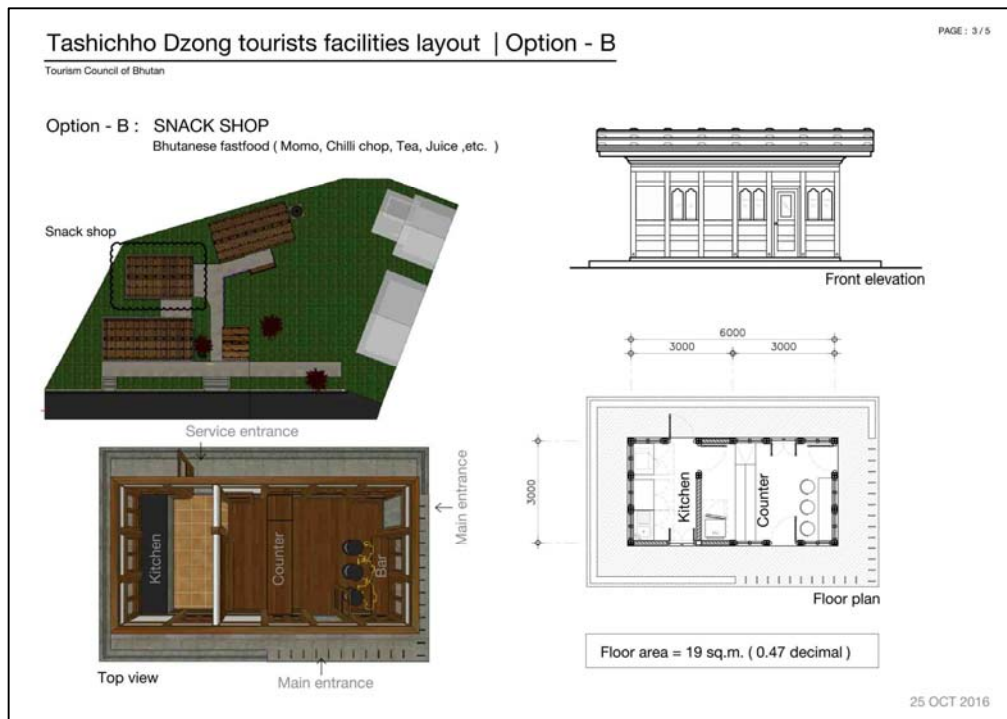
Figure Q5-28,29. Presentation of Tashichho Dzong snack shop.

Design development of Tashichho Dzong snack shop & cafeteria.

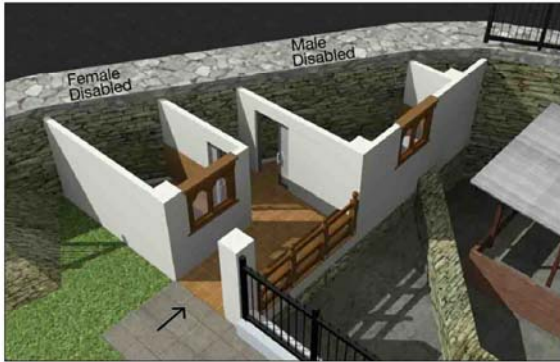
Figure Q5-32,33. Presentation of disabled restrooms at Memorial Chorten.

OPTION - A : 2 Disabled restrooms
with hidden restroom doors

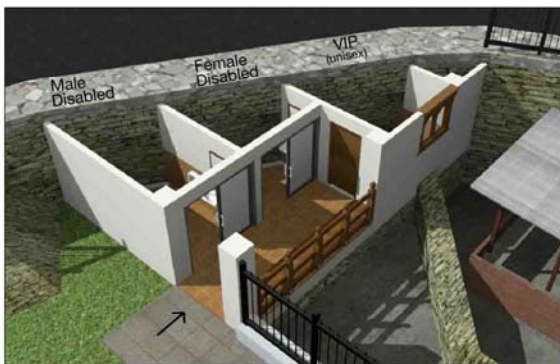
OPTION - B : 2 Disabled restrooms + 1 VIP restroom

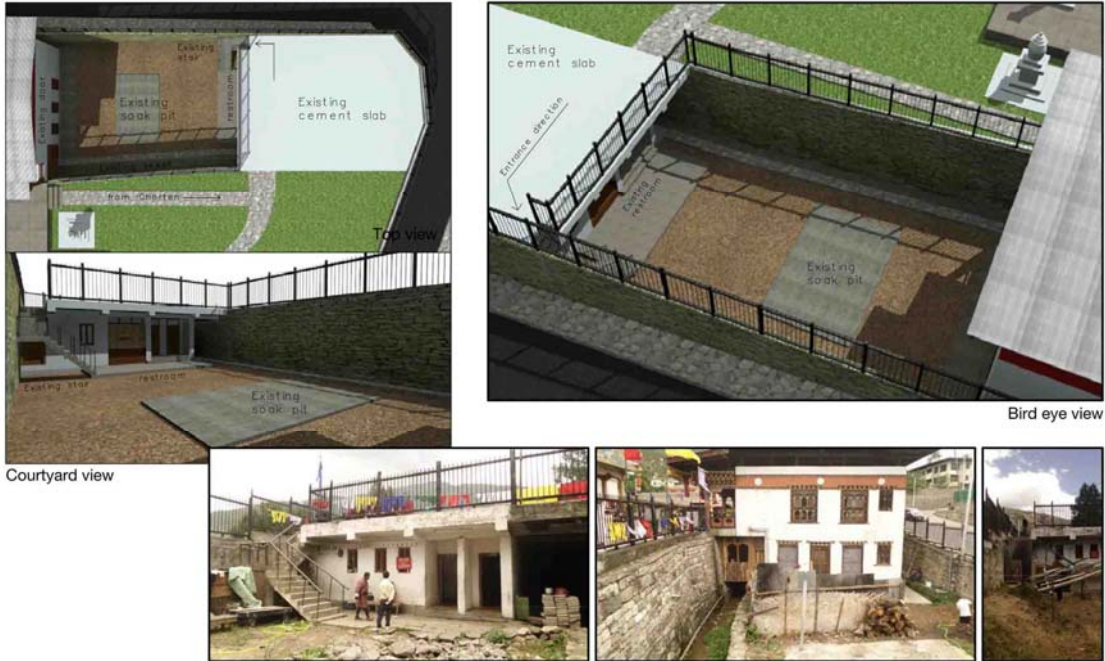
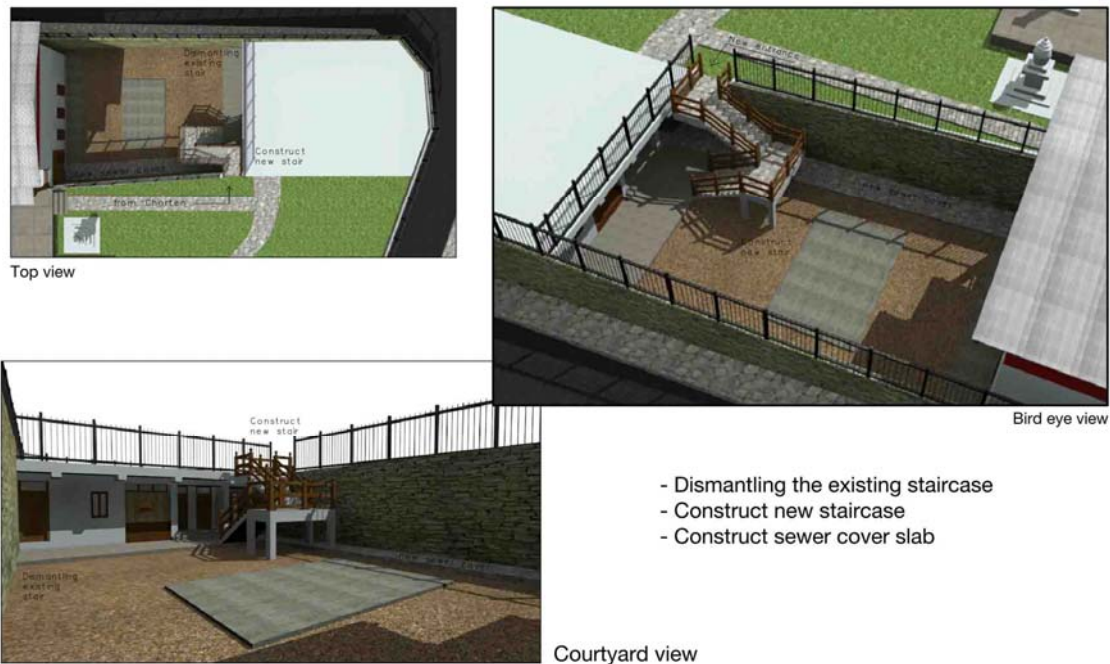
Figure Q5-34,35. Presentation of courtyard renovation at Memorial Chorten.

Existing site : The North-East corner of Memorial Chorten

Phase #1 : New access to restroom

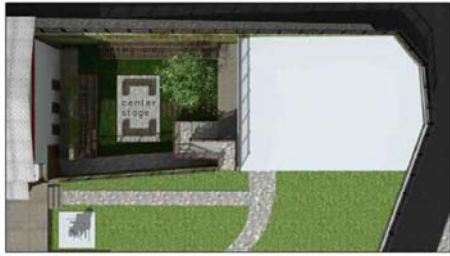
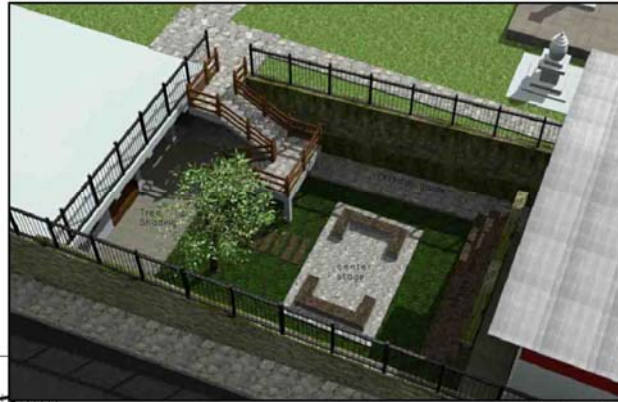
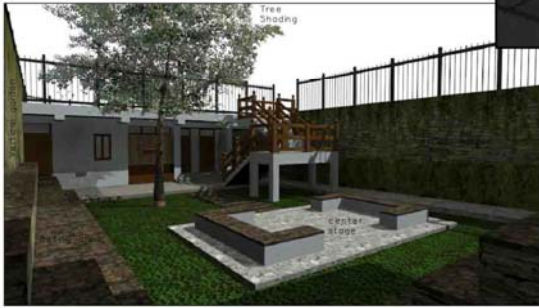
Figure Q5-36. Presentation of courtyard renovation at Memorial Chorten.

Phase #2 : Courtyard landscape

- Construct seats step
- Construct center stage on the existing soak pit
- Vertical garden and landscape decoration

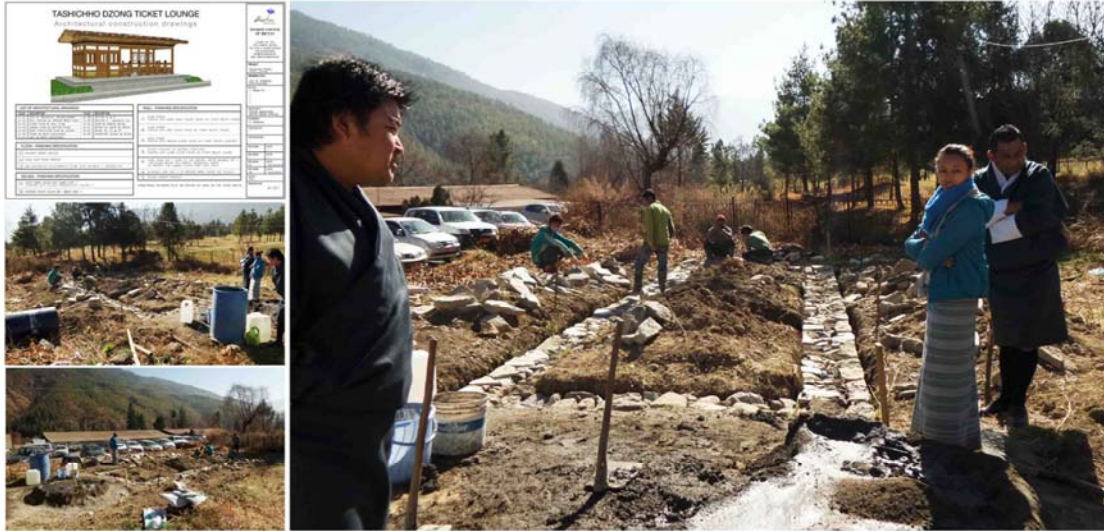
Figure Q5-70. Construction monitoring of tourists lounge at Tashichho Dzong.

Project status : Foundation construction

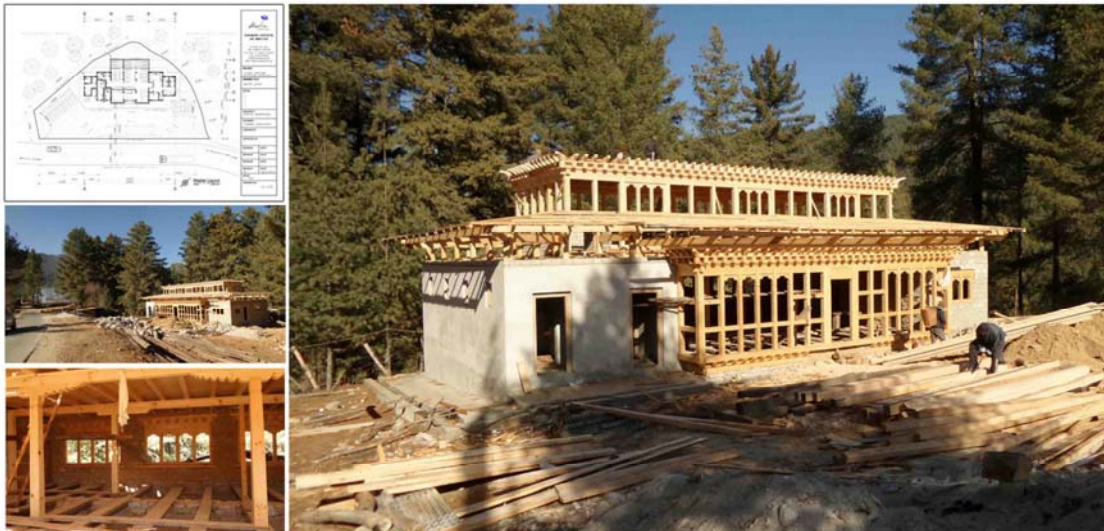
Figure Q5-71. Construction monitoring of tourists lounge at Tashichho Dzong.

Project status : Timber structures construction

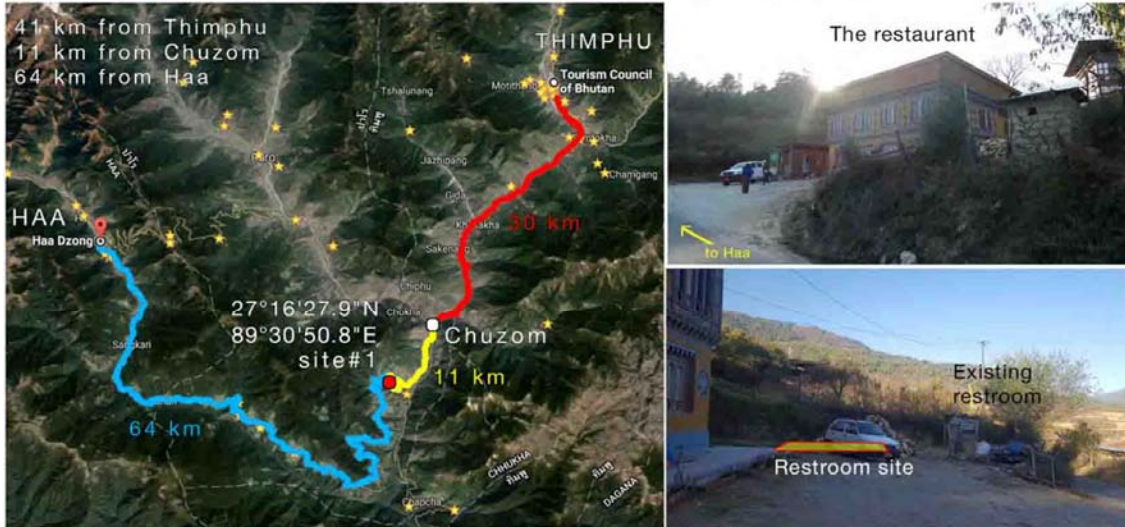
SITE#1 : Kunzang Wangmo Restaurant, Dawakha, Paro, 77290505

Site comments : - Available for a public restroom
 - Easy access and visibility from the public road
 - **Too closed to Chuzom.**

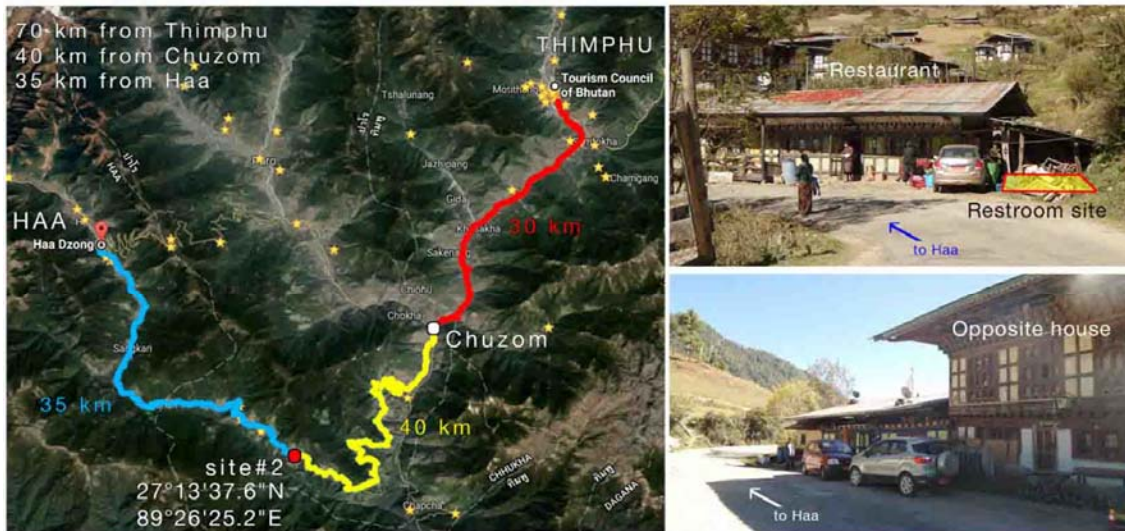
SITE#2 : Restaurant Rang sagang, Naja, Paro

Site comments : - **Not enough space for good restrooms.**
 - **No proper parking area.**
 - **Might be effected by road widening.**

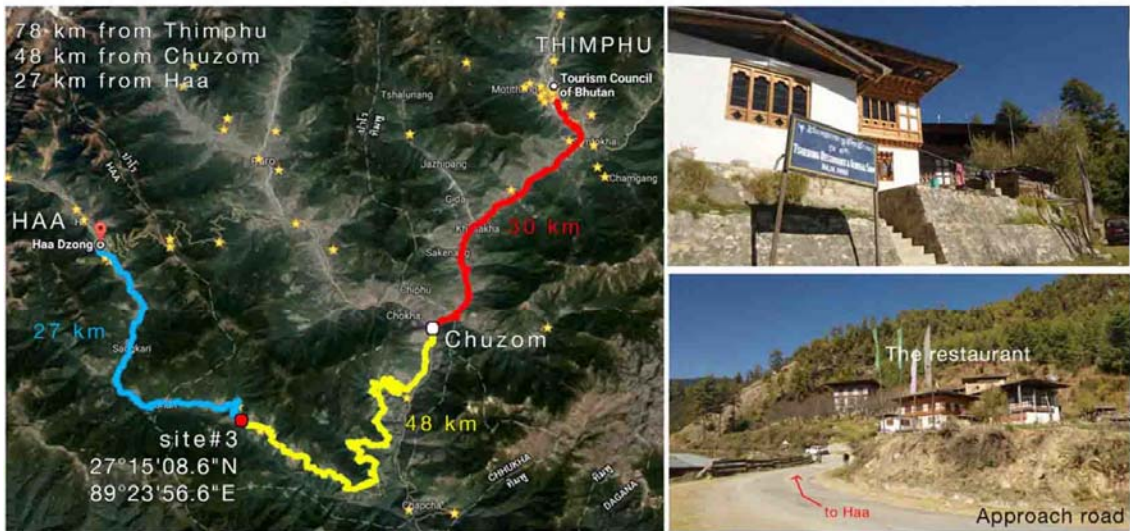
SITE#3 : Tshering Restaurant & Shop, Naja, Paro

- Site comments :
- Available for a small public restroom
 - Easy access and visibility from the public road
 - **Tourists need to walk up from the stair to the restaurant level.**

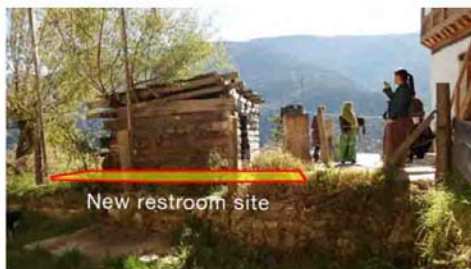
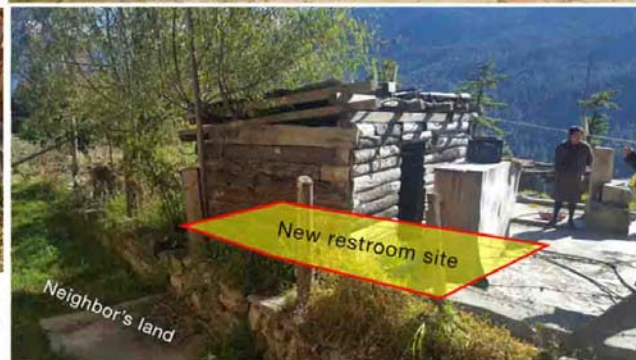
New restroom site

Dismantle the existing timber storage and construct new restroom parallel to the fence.

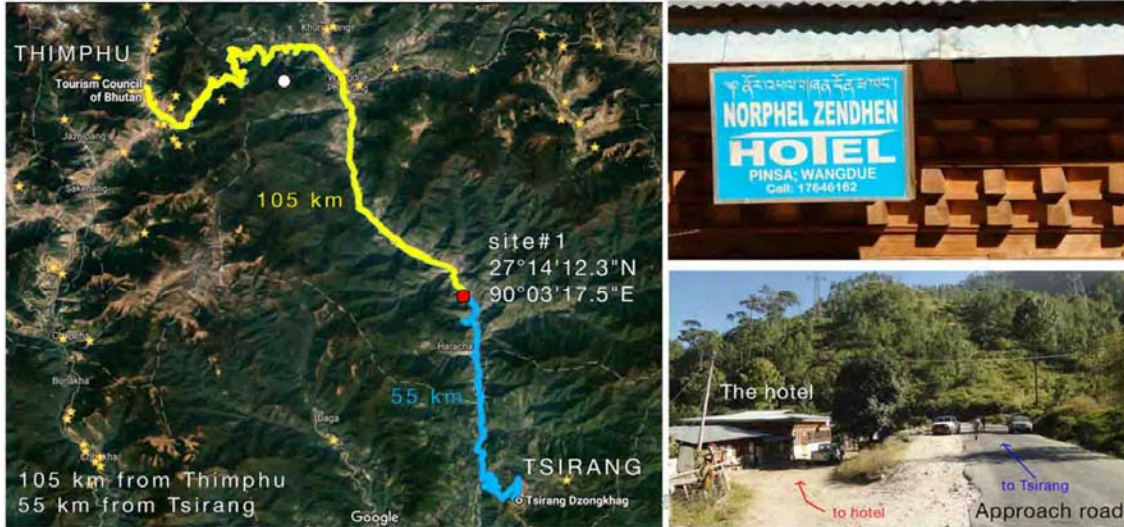
SITE#1 : Norphel Zendhen hotel
Pinsa, Wangdue, 17646162

- Site comments :
- Available for a small public restroom
 - Easy access and visibility from the public road
 - **Need back retaining wall**
 - **Might be disturbed by the next existing local restroom**

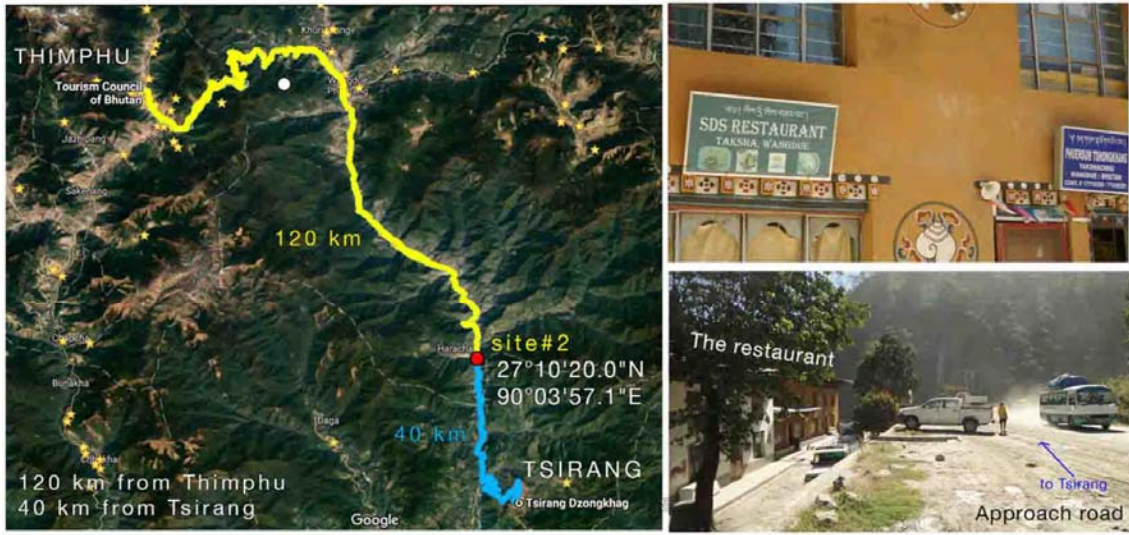
SITE#2 : Phuensum Tshongkhang
Takshachhu, Wangdue, 17710589

Site comments : - Available for a public restroom with parking
 - Easy access and visibility from the public road
 - **Might be disturbed by dust from the unfinished road.**

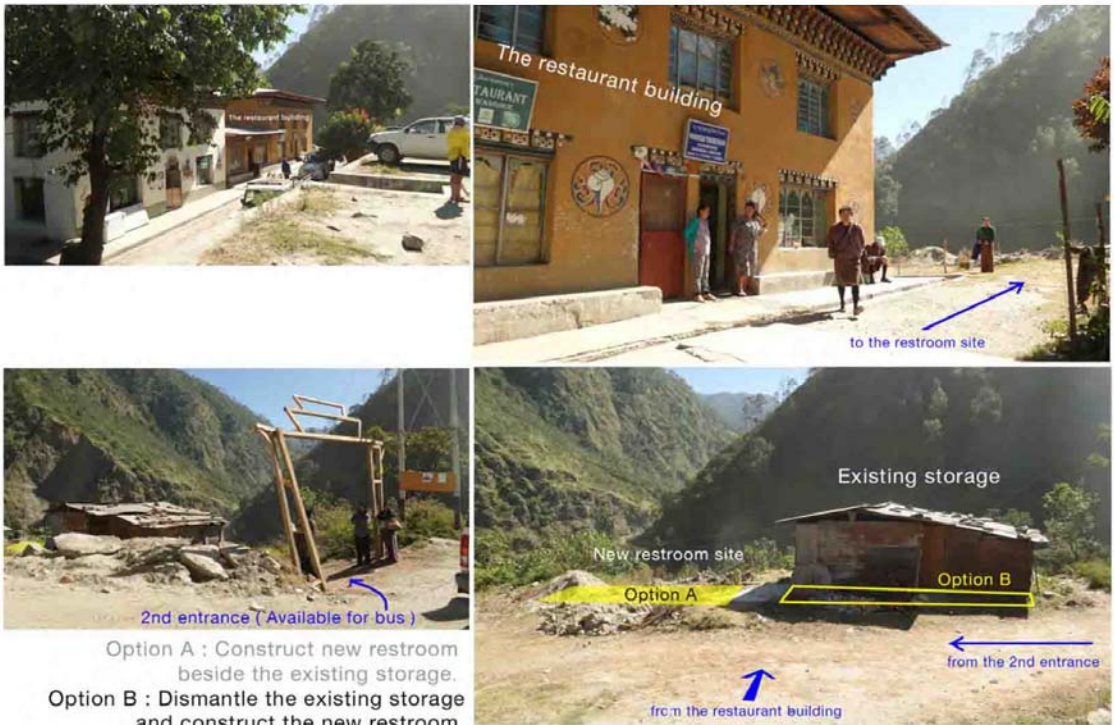
Figure Q5-76. Site survey of new public restrooms construction on Thimphu-Tsirang highway.

Option A : Construct new restroom beside the existing storage.
 Option B : Dismantle the existing storage and construct the new restroom for better appearance.

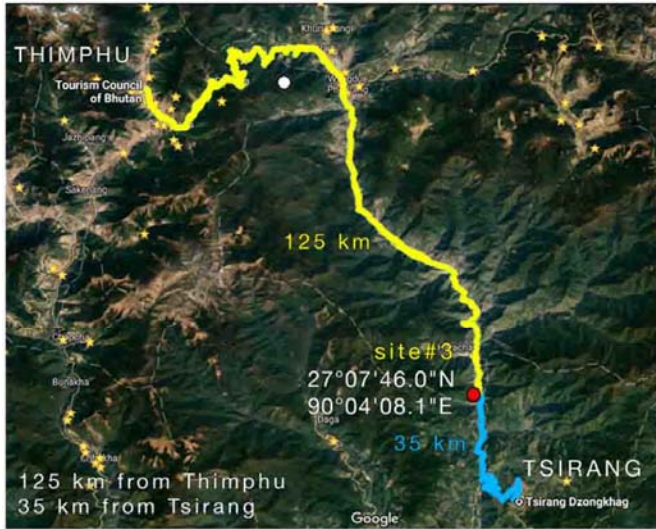
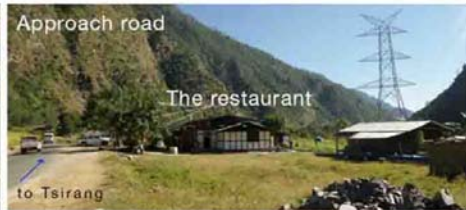
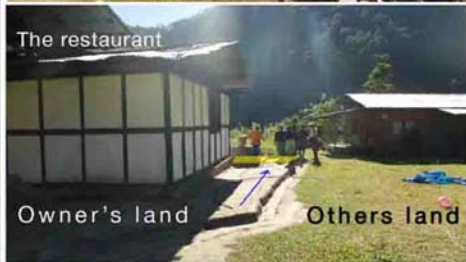
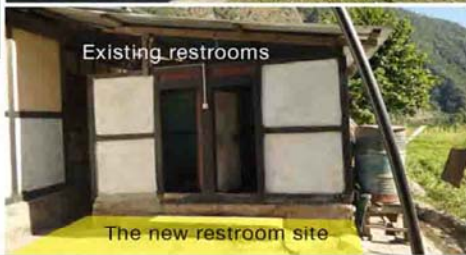
SITE#3 : Mindu Lham Restaurant & lodge, Rilangthang, Tsirang, 17622113

- The space is too small.
- Located at the back of the hotel ,cause poor visibility and difficult access.
- Located at the wash area and staff zone.

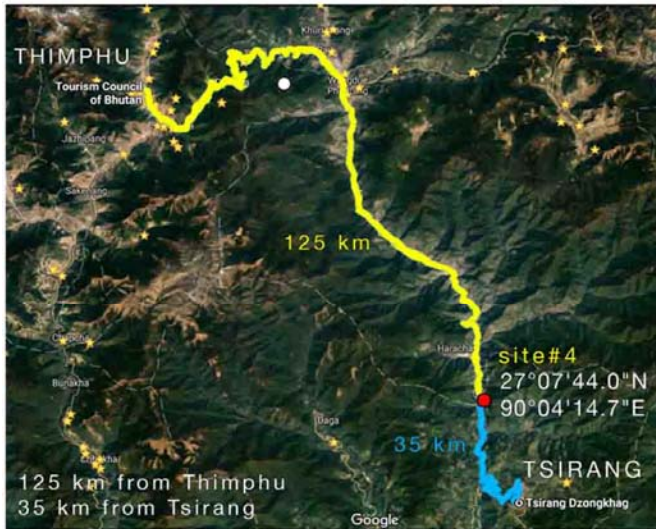
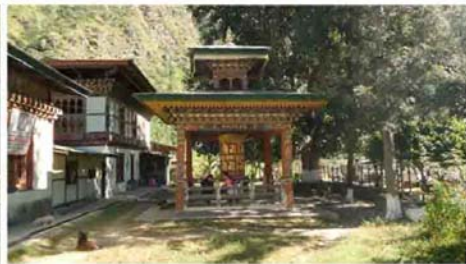
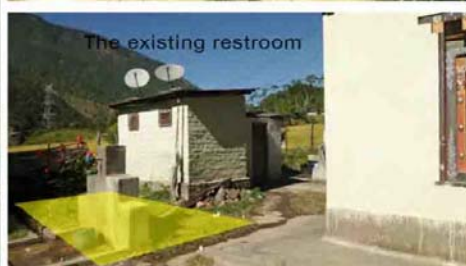
SITE#4 : Karma hotel & bar , Rilangthang, Tsirang, 17822974

- Good welcome space.
- The new restroom site is too small.
- The owner don't want to dismantled the existing restrooms for the bigger space.

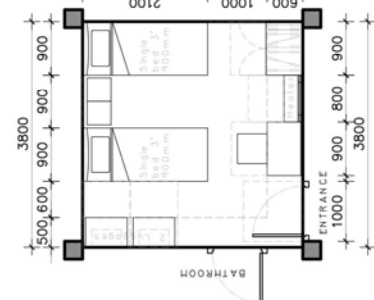
Double bedroom minimum area = 14.0 sq.m.

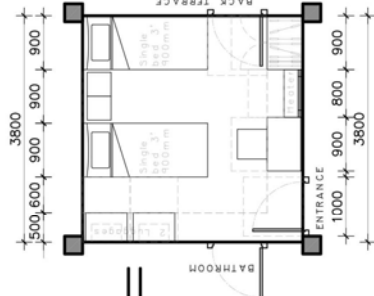
Twin bedroom Area = 14.0 sq.m.

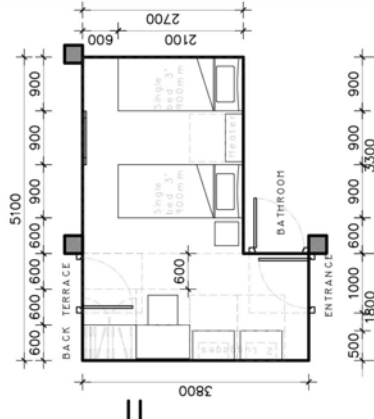
Twin bedroom Area = 15.8 sq.m.

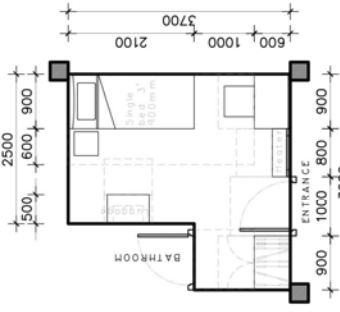
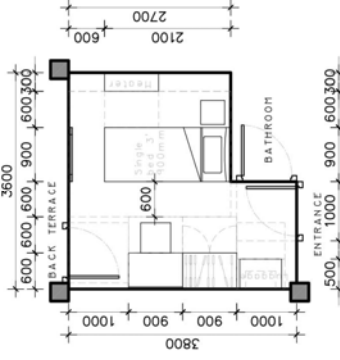
Single bedroom
minimum area = 9.0 sq.m.
